Curtain Wall Refurbishment *A Challenge to Manage*

preservation technology
dossier 1
january 1996

Proceedings International DOCOMOMO Seminar, January 25, 1996, at the Eindhoven University of Technology, the Netherlands

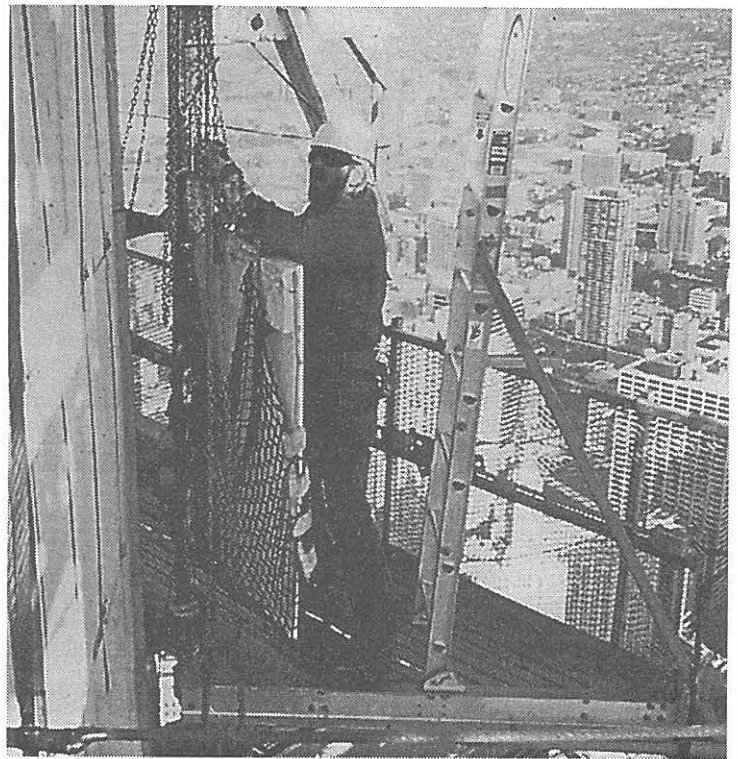
Marble panels being removed from the Amoco facade high above the streets of Chicago's Loop. Photo: Wiss, Janney, Elstner Associates, Inc.

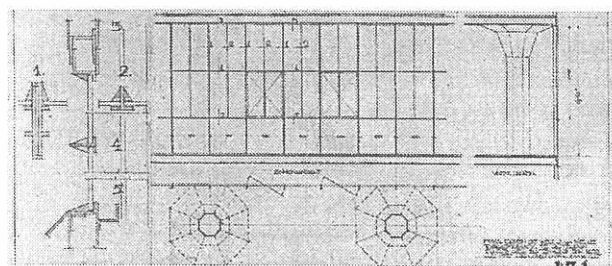
The construction of the curtain wall of the tobacco factory. Drawing: Archive Van den Broek & Bakema architects.

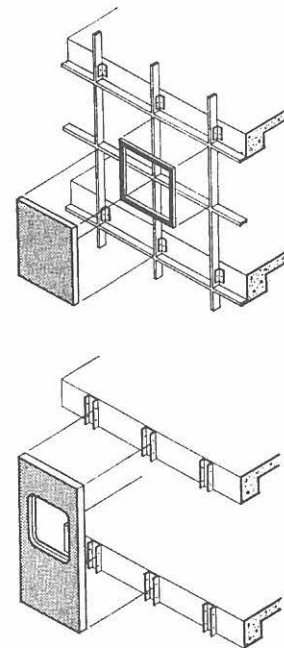
Analysis of light cladding by construction: a) stick construction, b) panel construction. From: R. Michael Rostron, *Light cladding of buildings*, London 1964.

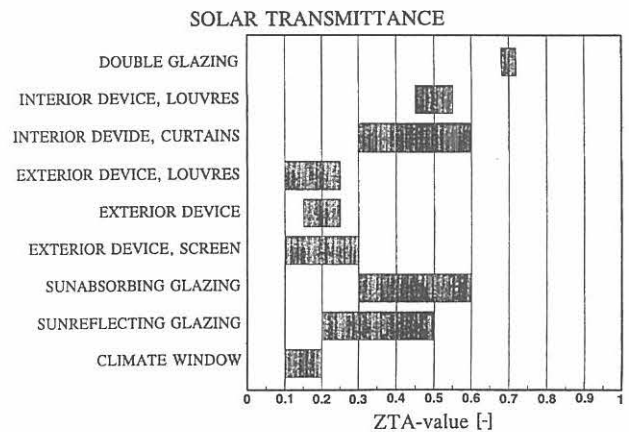
Fig.3 Solar transmission and sunshading. Graph: Peutz & Associés b.v.

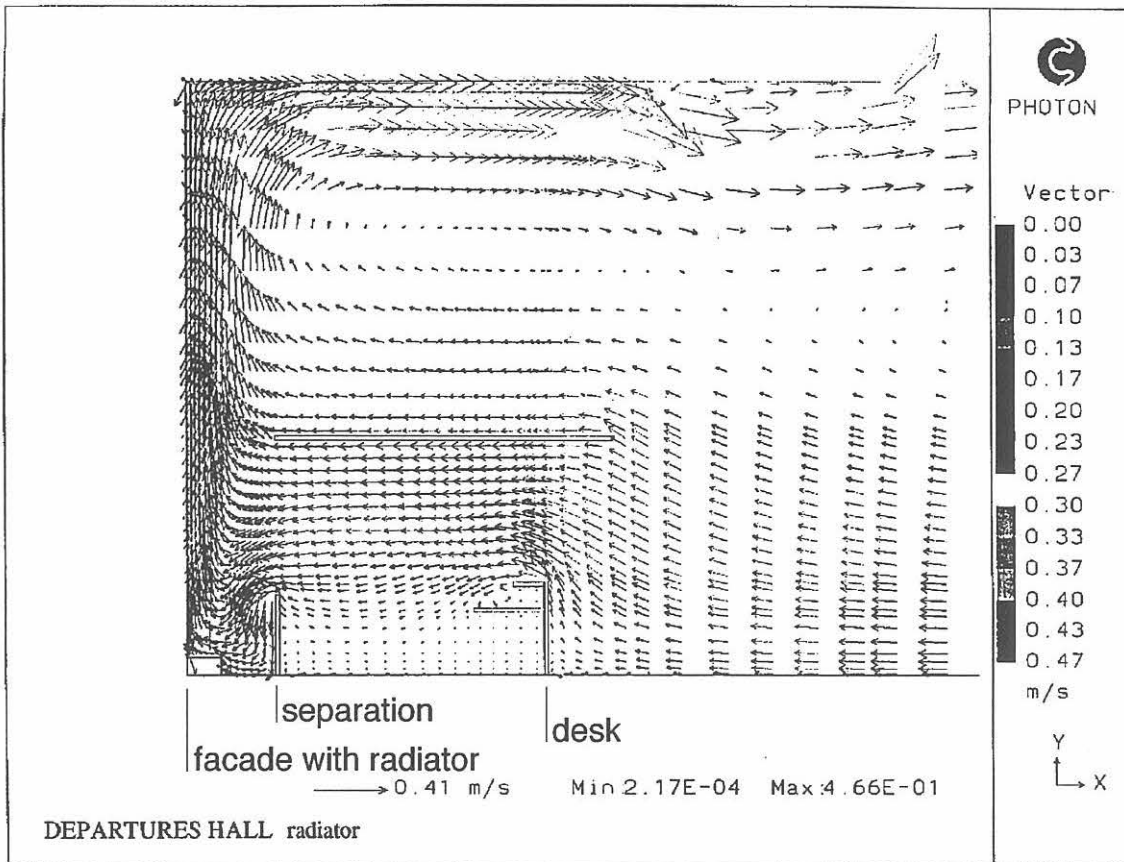
Fig.5 Airflow pattern in the Departures Hall at radiator heating. Graph: Peutz & Associés b.v.

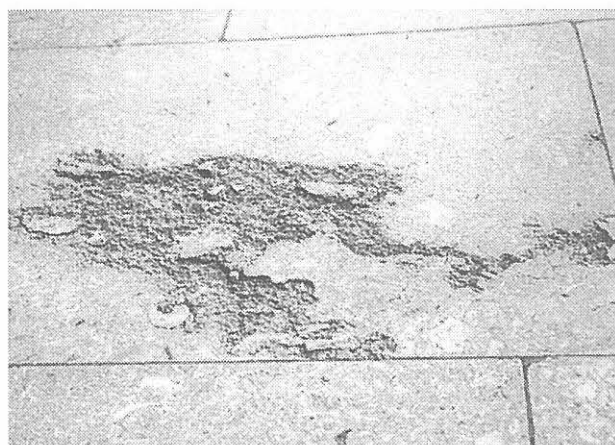
Spalling damage due to weathering to facebedded Derbyshire.

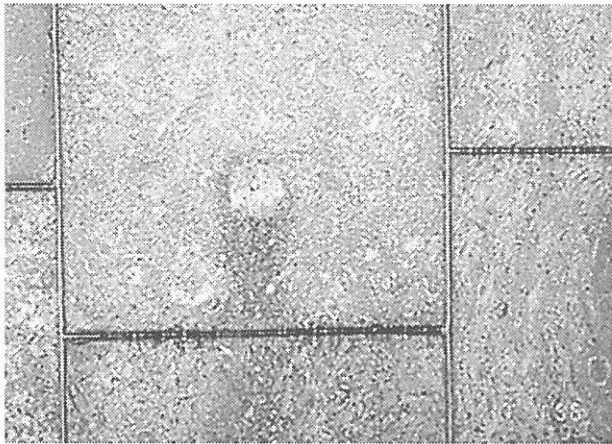
Face fixing has helped to stabilise stones, but visual quality of fixings is not good.

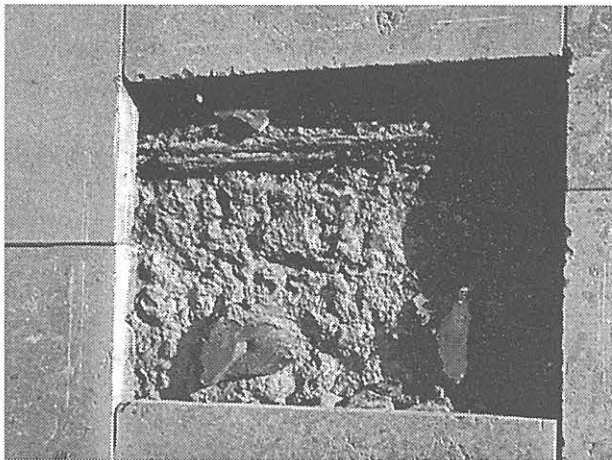
Removed stone highlights problem of corrosion of reinforcing steel in backing wall. Oxidation and expansion of steel has pushed stone forward.

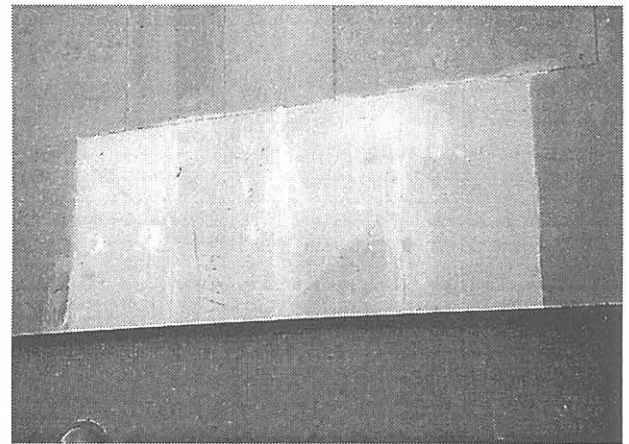
Replacement Portland stone on main wall. Note clean replacement stone contrasts with older dirty original stone.

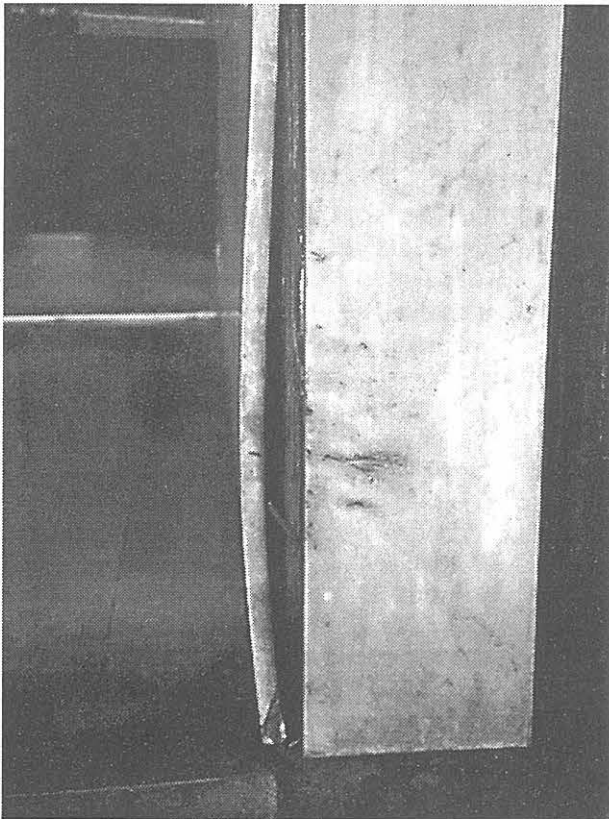
Bowing in thin marble cladding, due to excessive loading from overlying stone.

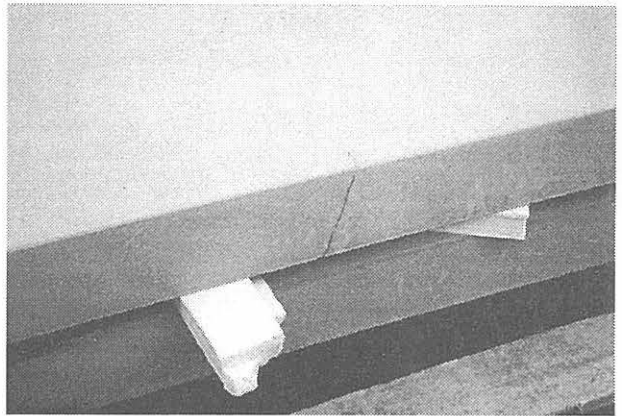
Natural crack in sandstone, due to absence of calcite within joint.

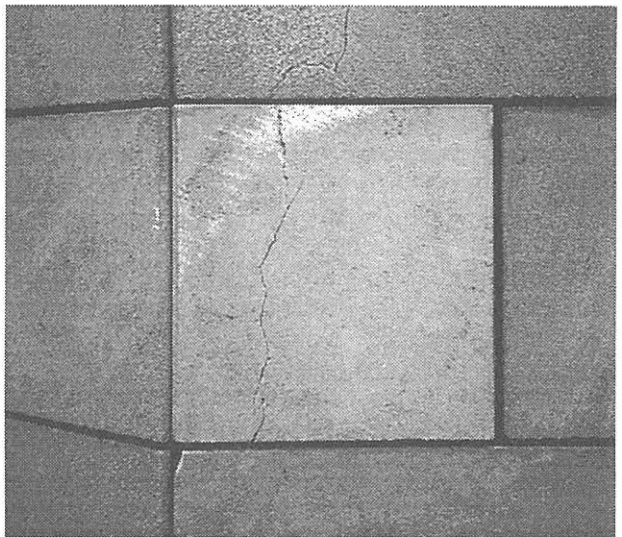
Cracking in sandstone, due to mechanical damage.

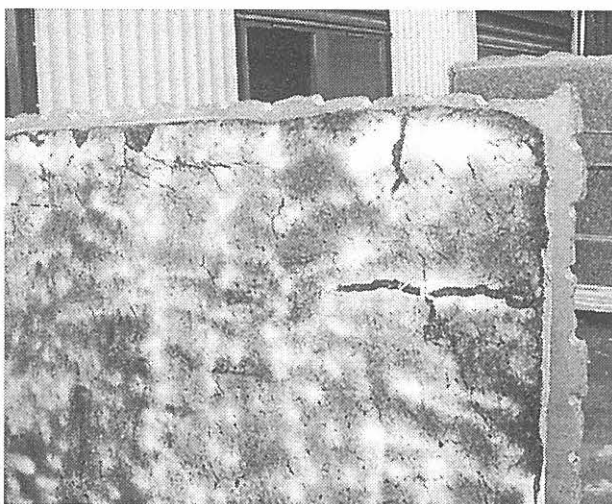
Cracking in granite, due to blast damage during quarrying. Note dye penetration treatment has been used to highlight cracks.

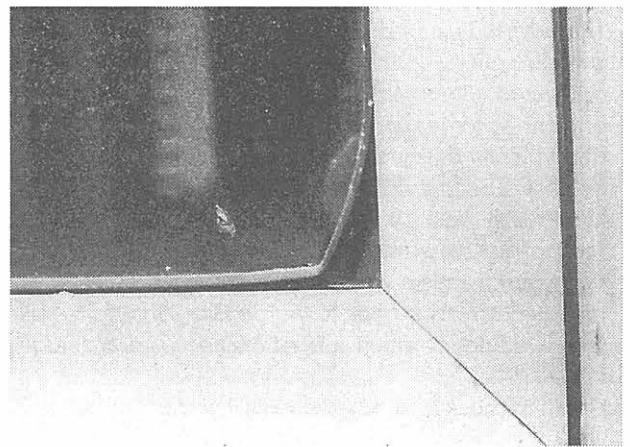
The photograph shows a dry glazing gasket which has pulled away from the corner of the window lite. This condition is a typical source of glazing leakage. All photos: Wiss, Janney, Elstner Associates, Inc.

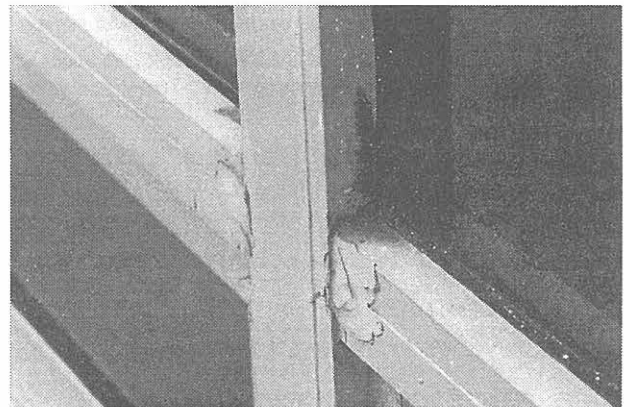
This remedial repair has sealed the weep holes and has rendered the interior drainage system ineffective. This type of repair can cause water leaks that were not previously experienced.

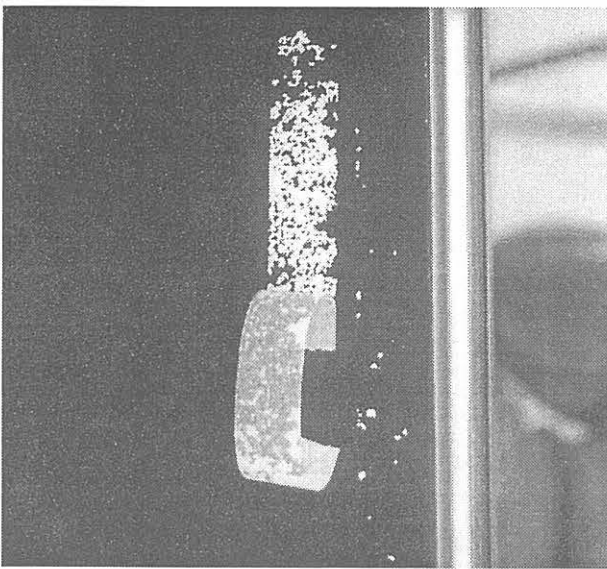
The testing procedure shown (adaptation of American Society for Testing and Materials or ASTM Standard D3359) illustrates failure of a factory applied paint coating due to improper

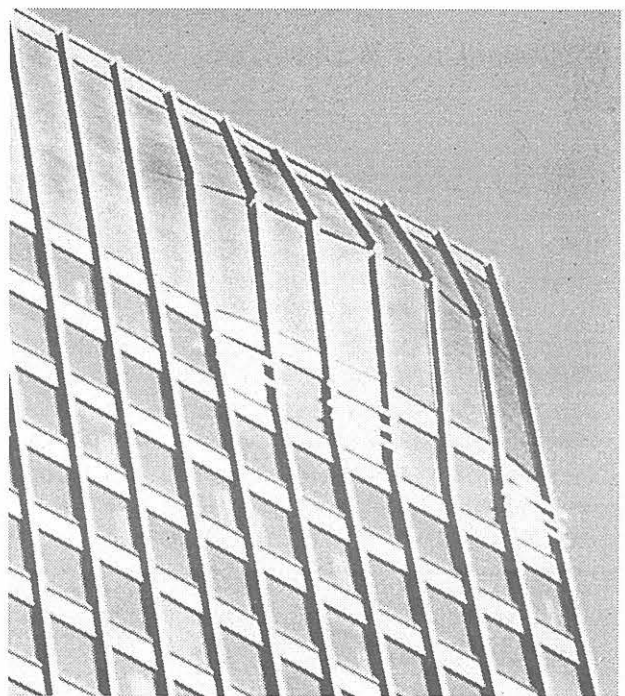
The curtain wall failure illustrated is located on the facade of a skyscraper where wind pressures are the greatest. This failure occurred at the connections that attached the curtain wall to the structural frame.

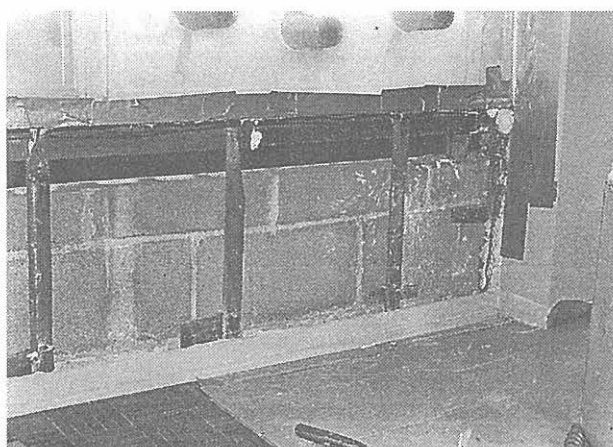
The interior finishes were removed at this curtain wall assembly to reveal the interior construction. In this case, the inspection opening was implemented in tandem with field testing to monitor leakage into the wall construction.

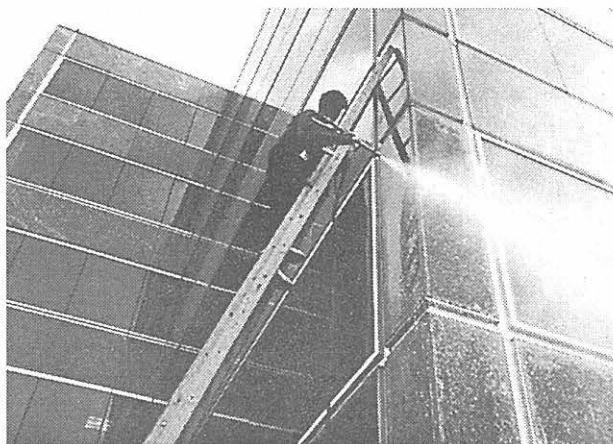
The testing procedure shown (AAMA 501.2 'Field Check of Metal Curtain Walls for Water Leakage') is one tool used in the field to locate the areas of water leakage or to test repairs.

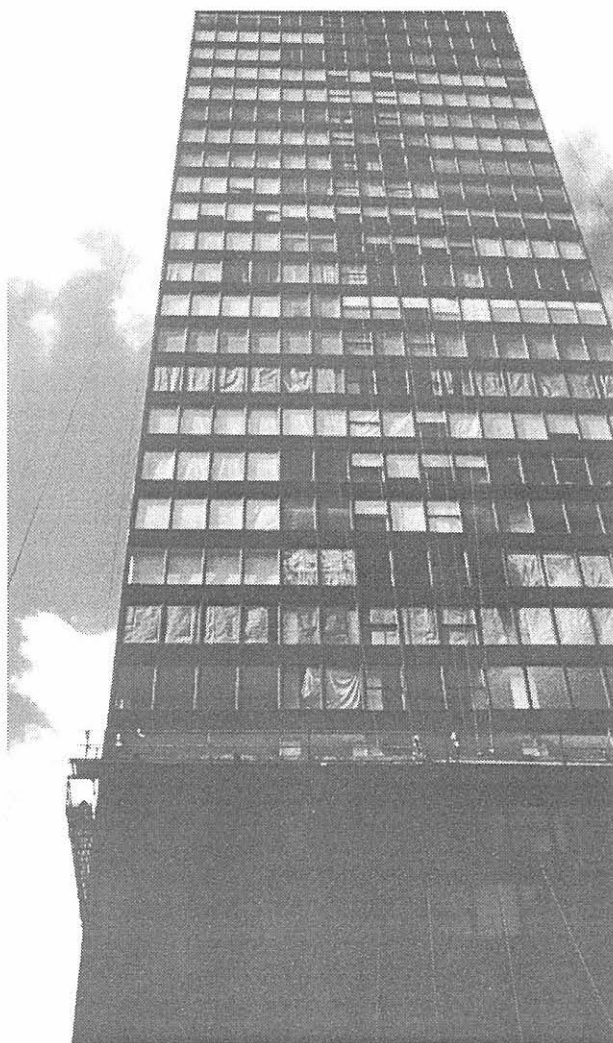
Full scale curtain wall removal and recladding has become a popular repair choice. In this case, curtain wall removal and replacement is occurring simultaneously.

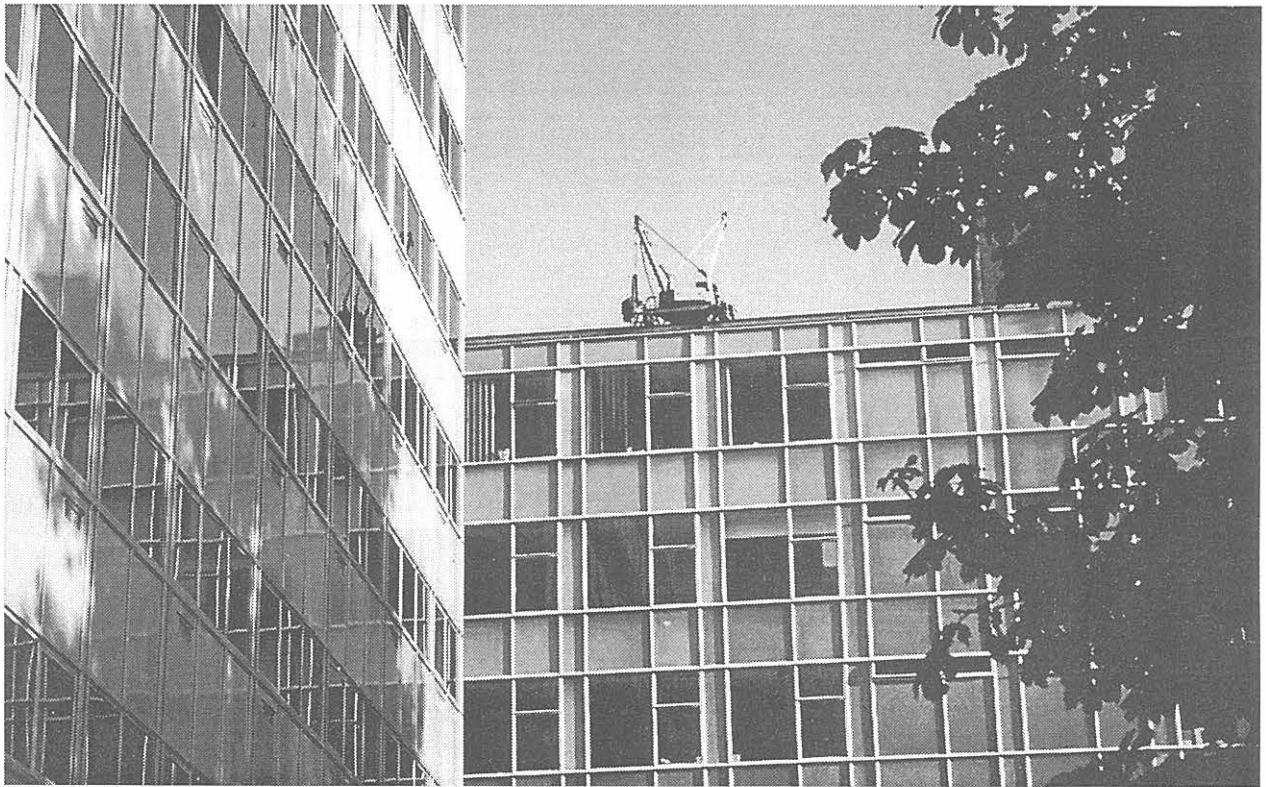
The original facade was very open, with two third transparent glass, and one third coloured glass for spandrels. The 1987 curtain wall, to the left, is extremely flush and has only one third vision panels. Photo: Wessel de Jonge.

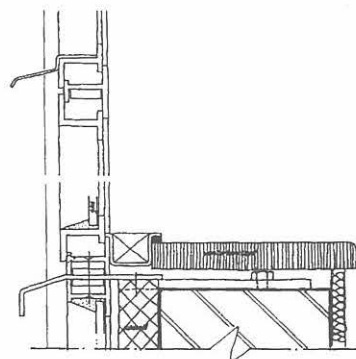
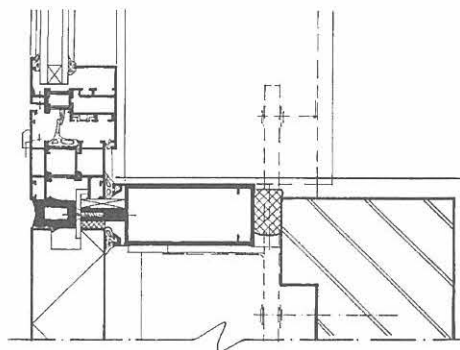
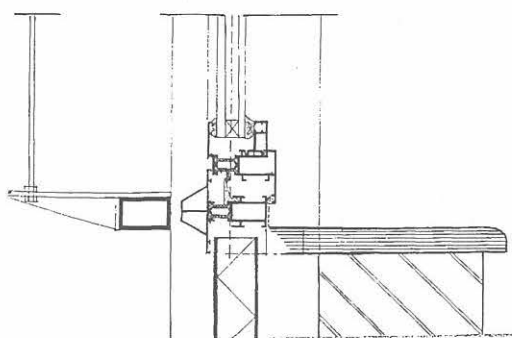
Top to bottom: Vertical section through the sill of the original facade of 1957, the 1987 renovation, and the recent refurbishment. Drawings: Wessel de Jonge.

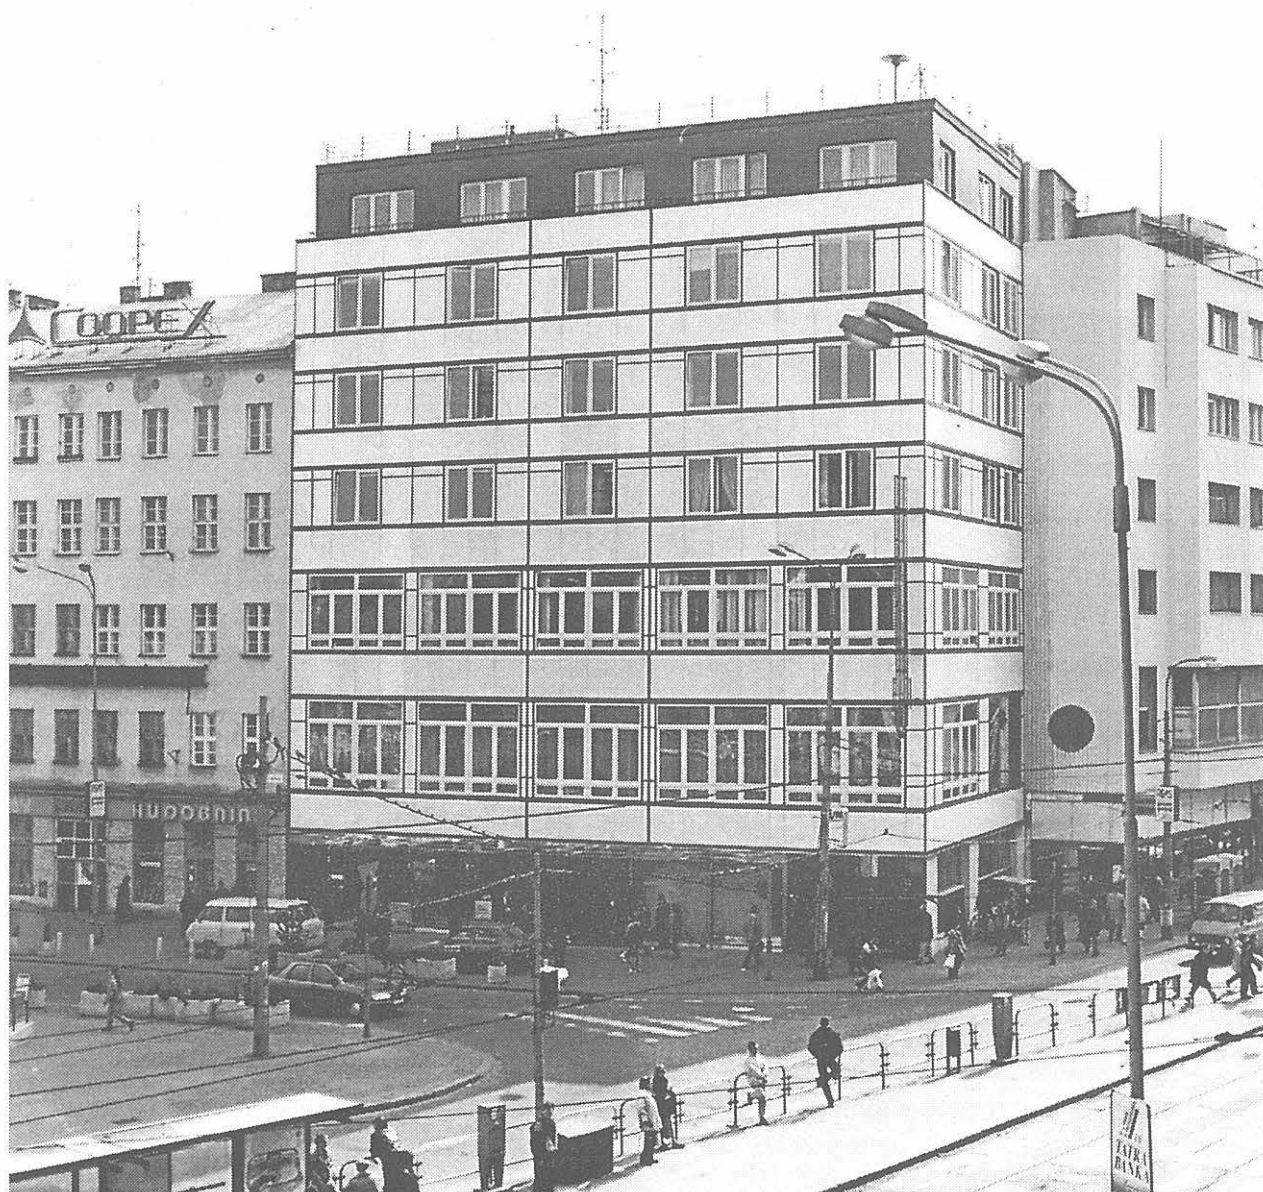
The City Savings Bank in 1995.

In the mid-1920s, Tvarozek tried to introduce a Slovak national style, based on traditional architectural elements and decorations. In Bratislava, we can still find several of Tvarozek's buildings with painted vaulted portals. Also the first project for the City Savings Bank was based on classic forms. Disposition and mass structures within the building were quite strictly limited by the client's requests and urban architectural requirements. The lot was quite narrow and the new volume was supposed to include a deep passage also. The architect segmented the facade by small windows, framed by mouldings. The ground floor was the only part of the building to have some large openings, yet still designed in a traditional monumental style. The front side was decorated with an impressive cornice. This concept was very similar to solutions presented by the architects F. Wimmer and A. Szonyi, who also entered for the bank's competition in 1928. Tvarozek, the winner of the competition, however implemented a more modern concept in 1930 and radically changed the idea of the facade. His solution of a curtain wall had never been used in Slovakia before.

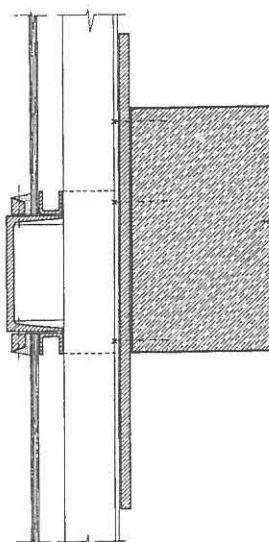
A vertical detail of the anchoring of the suspended facade frame. Drawing by the authors.

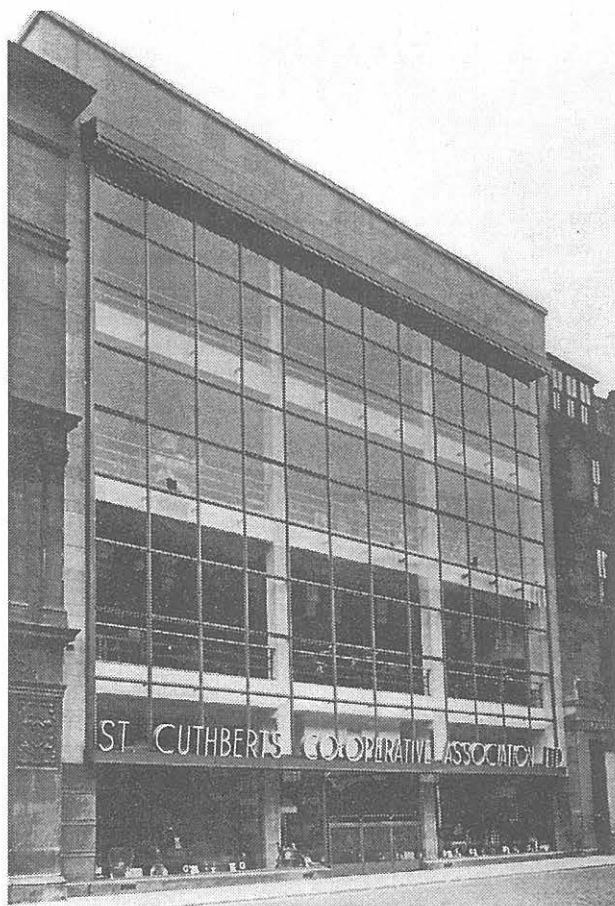
St. Cuthbert's Co-operative Association Department Store in Edinburgh, designed by Thomas P. Marwick and Sons in 1936. Photograph taken shortly after completion of the building. Photo: British Architectural Library, RIBA, London.

To the Bread Street facade, the narrow flanking piers and parapet around the central curtain wall 'window' are of brick construction, faced with grey granite in banded courses. Bronze sashes are cantilevered from the structural steel framework with attachments to stanchions and floors at regular intervals. The soffit of the continuous bronze canopy to the top of the curtain wall provided a facility for floodlighting the facade. The original shopfront below comprised plate glass, stainless steel and bronze components. Unfortunately the distinctive external cellulosed finish sign lettering above the entrance has now been replaced.

Unfortunately alterations to the facade (1961, 1964 to the shopfront, entrance doors, replacement of external signage lettering; 1988 general alterations and painting of portions of the glass curtain wall) coupled with change of use to a Paintball Warfare Centre leave current perceptions of the building dulled and negative. The 1937 facade is at present Category 'A' listed and any future development which recaptures the original's daring and unashamedly 'modern' vision for transparency between building and street, fusing exposed frame structure, interior open space and exterior skin through the materials, detailing and integrated use of lighting would be very welcome.

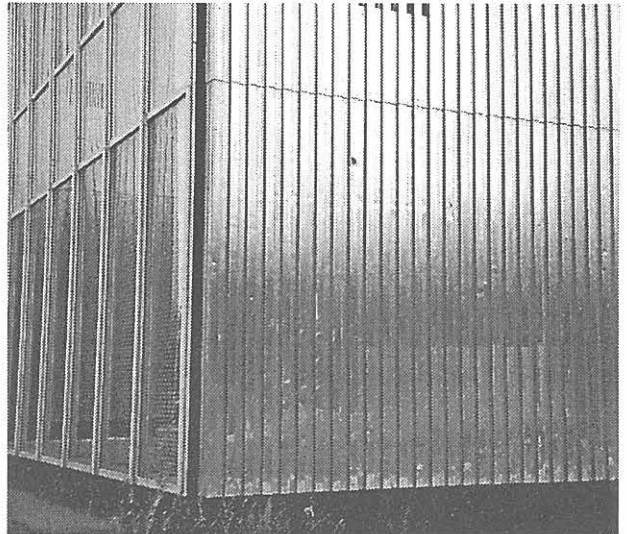
The dented Remanit panels on the end facade are witnesses of the past and add a pleasant flavour to the renovated Thyssen Haus. Photo: Wessel de Jonge (1996).

The end facades of the building's three slabs are clad with Remanit, a relatively light yet durable metal alloy. Remanit is highly resistant to weathering and immission, and it is easy to maintain. Even after forty years of service, the condition of the corrugated cladding was satisfactory and replacement was

therefore unnecessary. The steel cladding has been taken off, and reinstalled after extensive checks and minor repair work. Today the minor dents in the remanit panels add an appealing flavour of authenticity to the perfect shape of the exterior of the renovated Thyssen Haus.

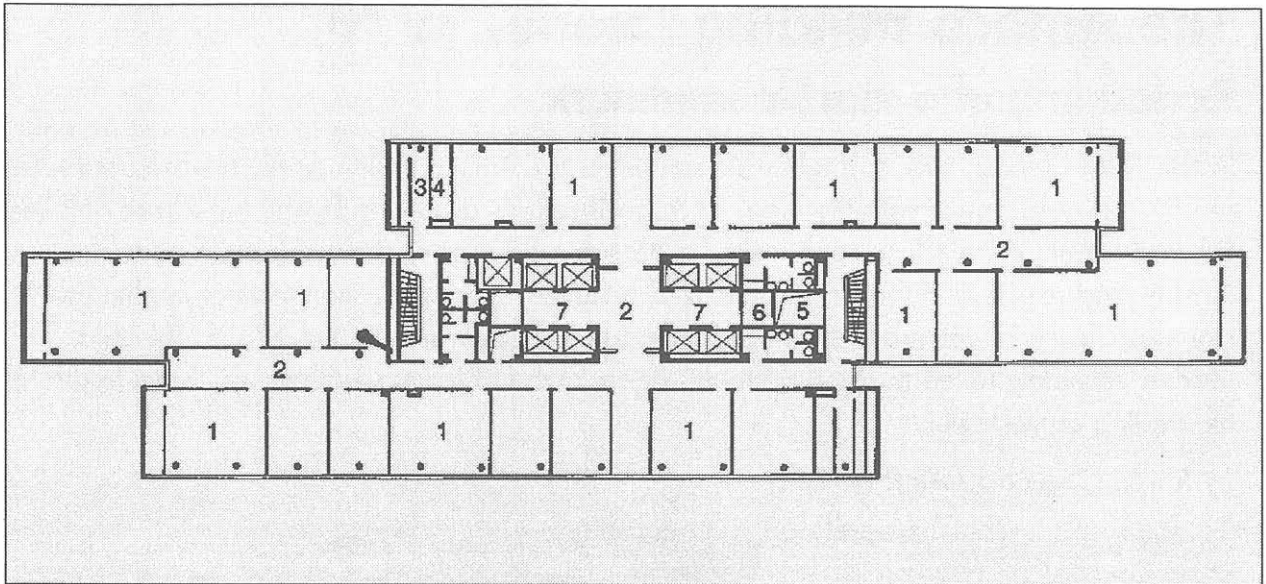
Ground floor plan. Typical floorplan of Thyssen Haus after refurbishment: 1) Offices, 2) Corridors, 3) Kitchen, 4) EDV, 5) Service shafts, 6) Services, 7) Elevators. Drawing: HPP Architekten.

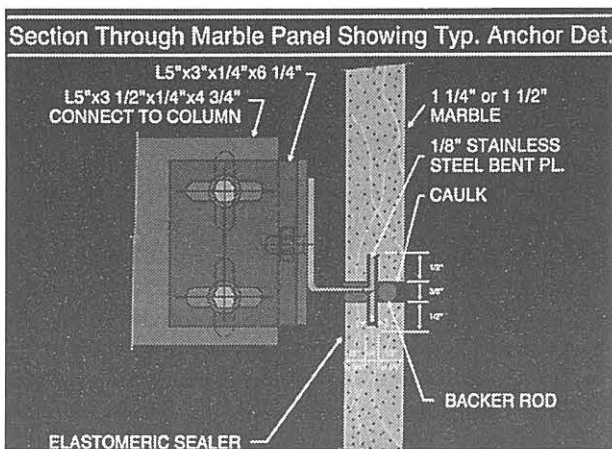
Marble panels suspended from the columns by a series of galvanized clips and stainless steel shelf angles.

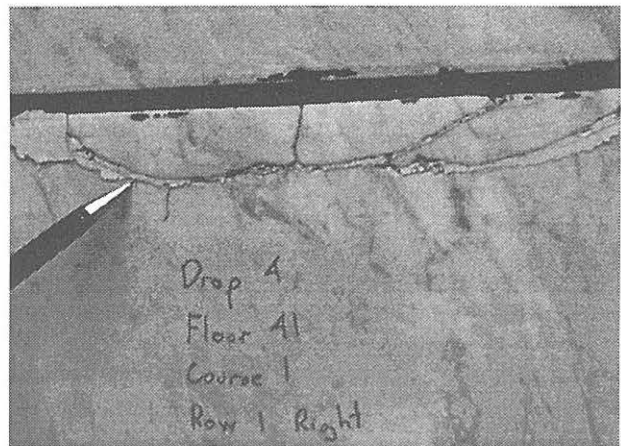
One of the marble panels with crescent shaped cracks at the kerfed connections.

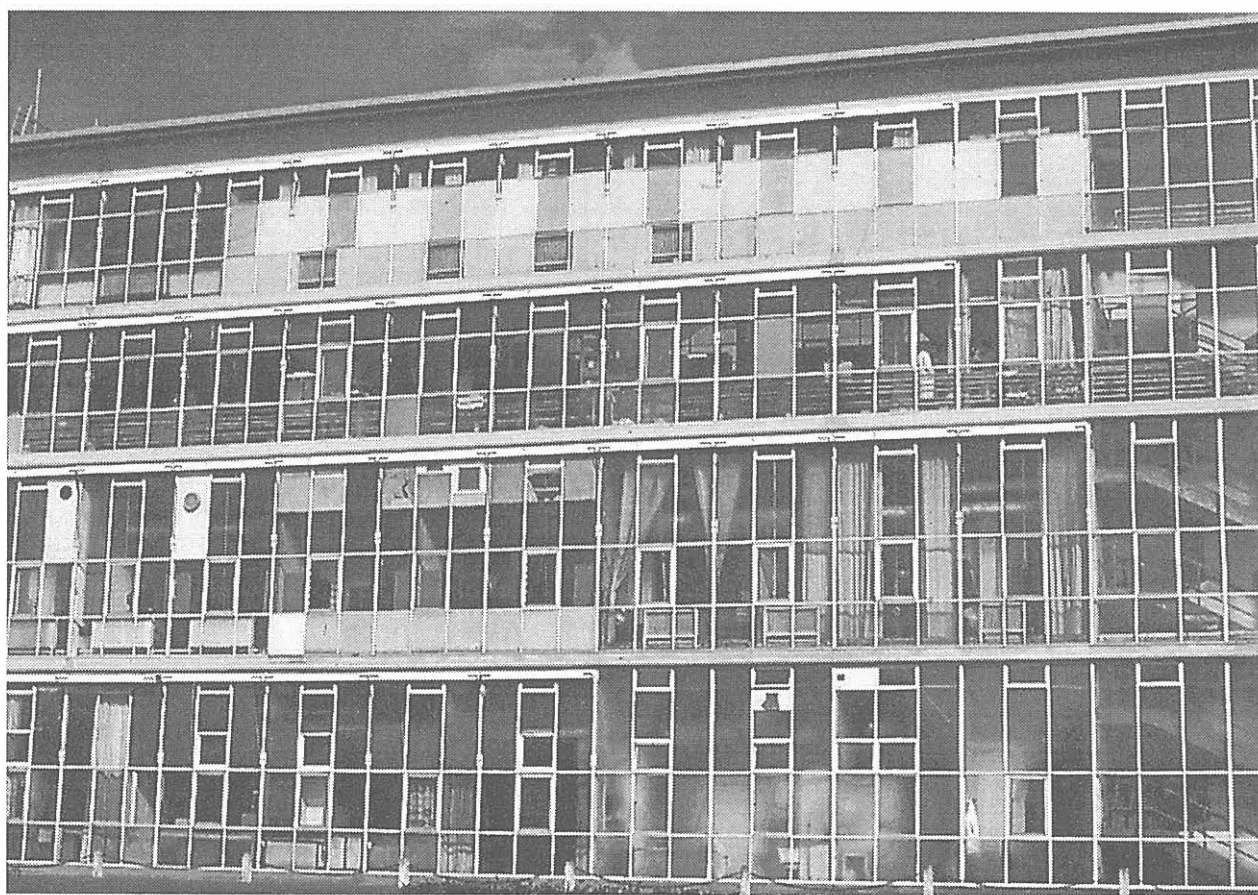
The Boots Factory with original glazing before renovation, with opening lights and structural mullions between the three window bays.

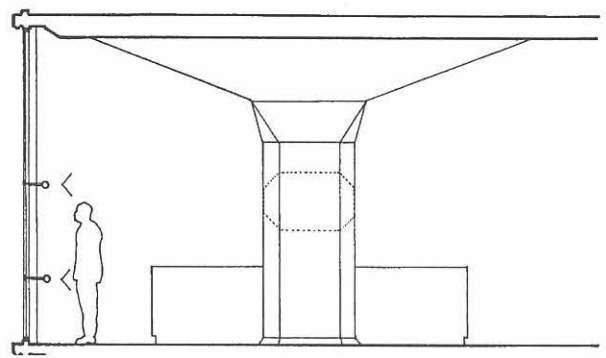
New glazing based on standard W 20 sections with horizontal structural bars.

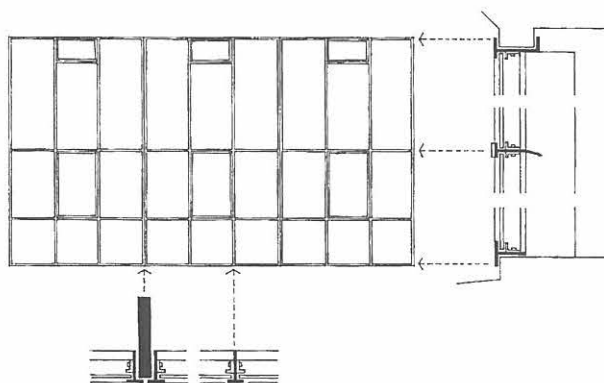
Original glazing with opening lights and structural mullions between the three window bays.

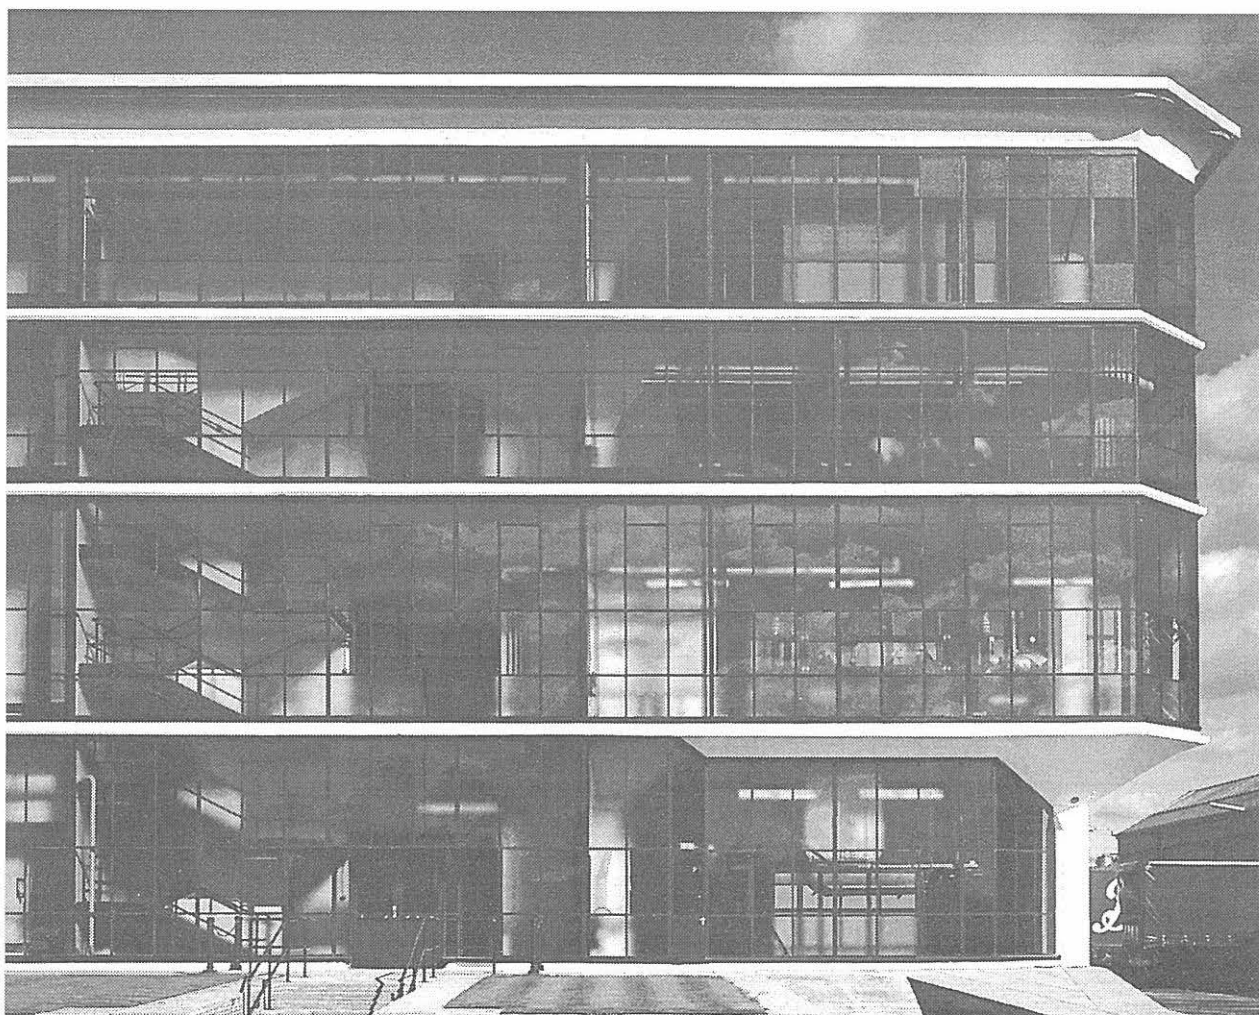
The completed scheme. The sunreflective glazing has a neutral grey tone of only 10%, but still results in a significant loss of transparency. Photo: Martine Hamilton Knight, courtesy of the Boots Company.
