The Fair Face of Concrete
Conservation and Repair
of Exposed Concrete

preservation technology
dossier 2
april 1997

Proceedings International DOCOMOMO Seminar, April 8, 1997, at the Eindhoven University of Technology, the Netherlands

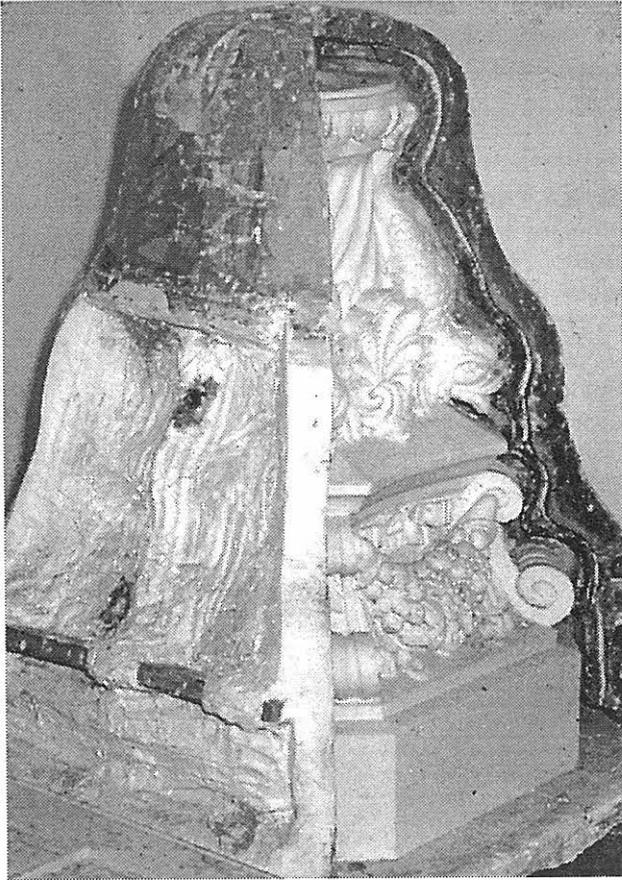
To produce elaborate units with a great deal of undercut complex forms that could be released in sections moulds were made out of plaster, wood and natural fibers. Manufacturing cast stone of elaborate configurations and details - with some stylistic changes - remained common till the beginning of World War II. The form and unit are from a private residence in Florida. Photo: J.Fagin.

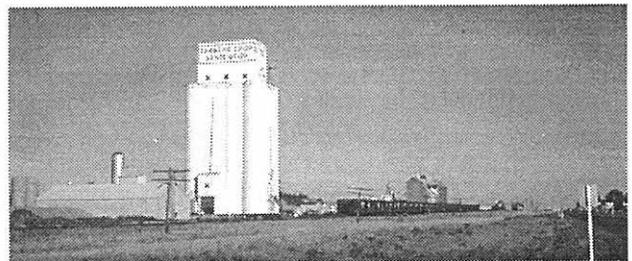
McLaughlin, South Dakota, grain silo. With the grain elevator, the grain silo was typically made of reinforced concrete because of concerns for durability and fire. Many silos once dominated the Great Plains in the United States. Photo: E. DeLony, HAER.

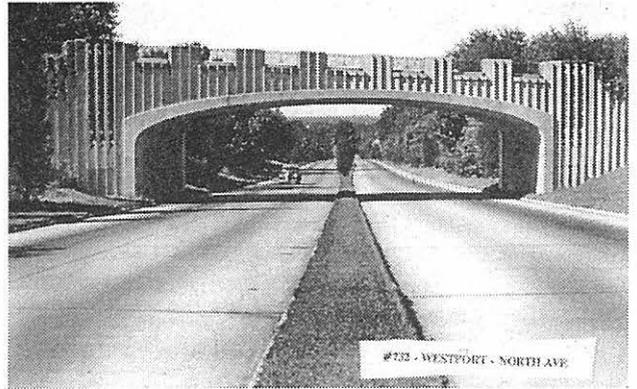
Merritt Parkway, North Avenue Bridge, Westport. The parkway was completed in the 1930s when traffic volume and speeds were considerably lower than today. All bridges are rigid frame and constructed in reinforced concrete. All bridges are embellished with extensive ornamental detail in either poured in place or cast stone. Details vary from bridge to bridge but all are inspired by the state of Connecticut, its people, history, flora and fauna. Photo: ConnDot, c. 1935.

Here, as in other public work projects of that era, the bridges were the result of a successful collaboration between an architect, George Dunkelberger, and the engineers of the state transportation department. While the basic structural frame was poured in place concrete, the wingwalls, abutments, railings, parapets and entrances were often embellished with decorative features. These decorative treatments were achieved in two ways, through insets or molds in the formwork or through the installation of off-site fabricated cast stone ornaments. The design of the ornaments created through reverse molds or profiles created in the formwork are generally simple without significant undercut. The cast stone ornaments can be very elaborate and have detailed configurations. The cast stone sections were either installed after the structure was completed or were placed integrally with the formwork before the structural frame was poured. In

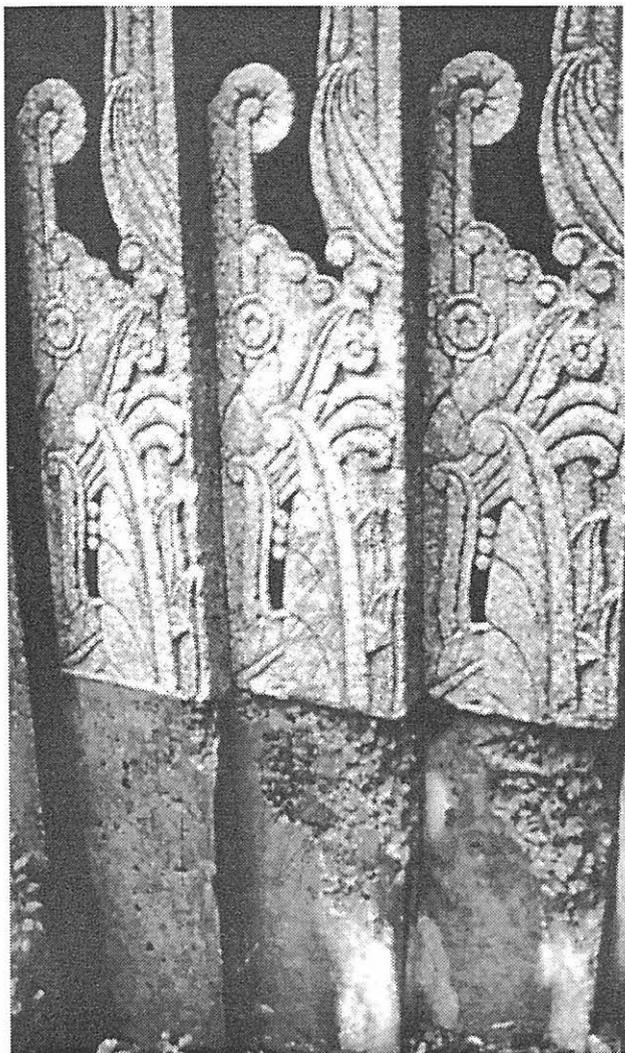
Merritt Parkway, North Avenue Bridge, Westport, sgraffito ornament. Different techniques were used to embellish the bridges. Sgraffito like the original Italian technique involved removing the outer layer of concrete to expose the darker colored inside to form decorative patterns. The concrete had to be poured in several different layers in a mold to achieve this effect. Photo: N. Wilks.

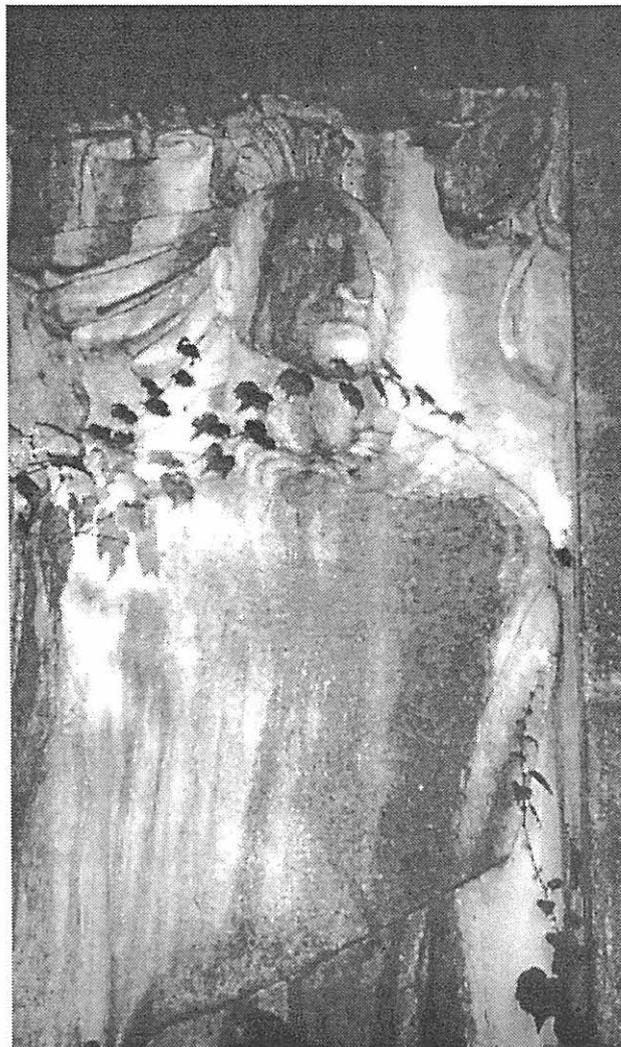
Merritt Parkway, Canstock Hill Road Bridge, Norwalk. The image of the native American which forms integral part of the wingwalls of the bridge has been eroded and covered with algae and moss as a result of excessive vegetation. The concrete itself remains in a remarkably good condition. Photo: N. Wilks.

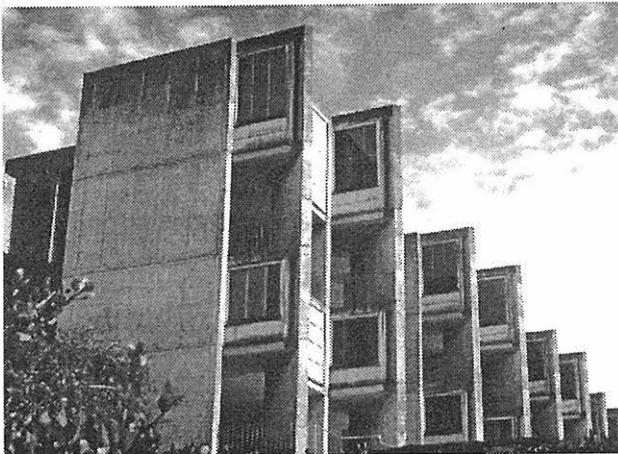
La Jolla, CA, The Salk Institute for Biological Studies. Designed by Louis Kahn between 1959 and 1965, the institute's buildings show the expressive qualities of reinforced concrete at its best. The uneven weathering and surface deterioration have further added to this expressive quality. Because of the monolithic appearance of this type of architecture, repairs will be more difficult to execute without a patch work appearance. In those instances, extending the repair work into the 'natural' lines of the design is one of the ways to minimize contrast between old and new. Photo: C. Hall.

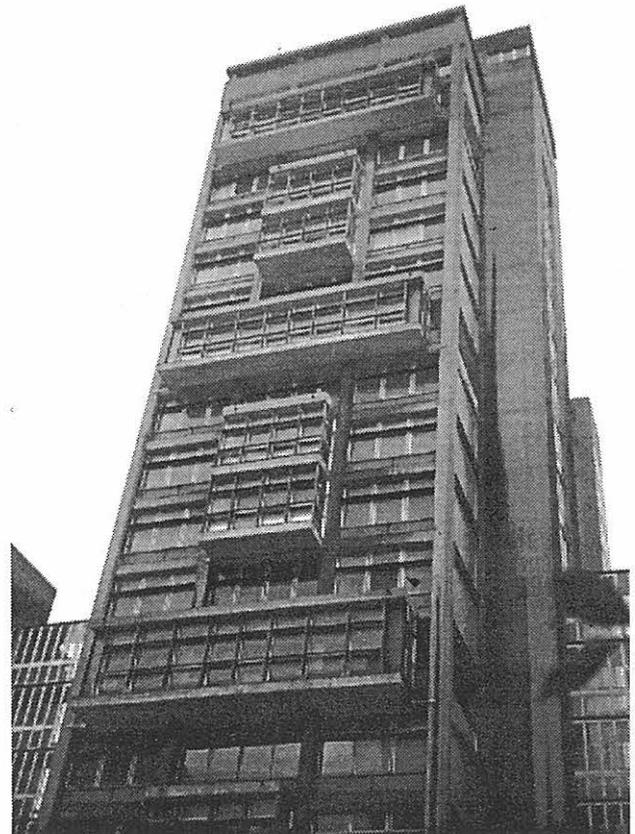
Ernö Goldfinger, Alexander Fleming House (1959-66). The complex combines a bush hammered *in situ* concrete frame with the Miesian curtain wall, granite-clad ground-floor columns, and exposed precast units. The retention of the original material aesthetic is now posing difficult conservation problems.

Alexander Fleming House suffers from the poor quality of the concrete and inferior workmanship typical of its date. The concrete required extensive patch repairs and has been coated with an opaque elastomeric coating to mask the patches and micro-cracking.

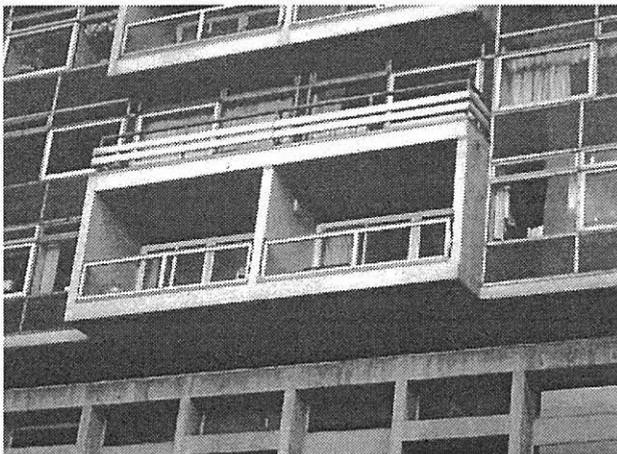
Centrepoint apartment building, Richard Seifert, 1961. The detachment of the mosaics is confined to the balcony areas, where the application method and unsuitable weathering details are unsatisfactory. Addressing the cause of the problem rather than the symptom will ensure a more acceptable result.

Following extensive discussions with English Heritage the importance of proper analysis was recognized, and suitable investigation work was initiated. This proved that the concrete structure was in fact in excellent condition, and the problems associated with the mosaic were a result of its original method of application. Much of the mosaic was still firmly adhered, and detachment was found to be confined principally to the balconies where the application problems were exacerbated by poor weathering details. It was anticipated that the proposed coating would 'waterproof' the structure, thus preventing further damage to the underlying concrete and detachment of the mosaic. The repair did not address the problems, and, in spite of the use of an etching primer, the sample coating panel proved the coating peeled off easily.

Minor structures on the roof (lift hoist and plant rooms), which are not visible from ground level, have suffered extensive loss of mosaic and potentially could supply the missing areas of mosaic for the balcony areas. Understanding the hierarchies of significance

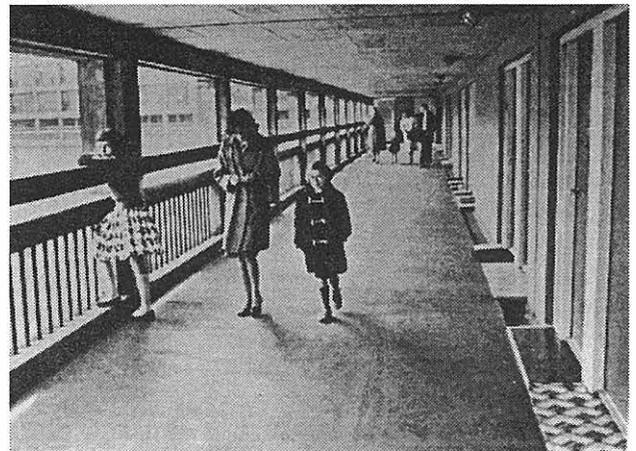
The deck walkways at Park Hill with the original concrete balconies, which can be considered as a series of precast components. Photo: Roger Mayne for *Architectural Design* of September 1961.

Inspection revealed that the condition of the balconies varied greatly. Some were in a very poor state, but many were in reasonably good condition, with limited elements of their constituent parts requiring attention. The balconies could be seen as a series of precast items (balustrades, support beams and uprights), which could be repaired or replaced individually. This could reduce costs. Understanding the design of the balconies and their construction, and adopting a designed solution rather than merely responding to the technical problems, has ensured a more satisfactory alternative to the metal balconies that were initially proposed.

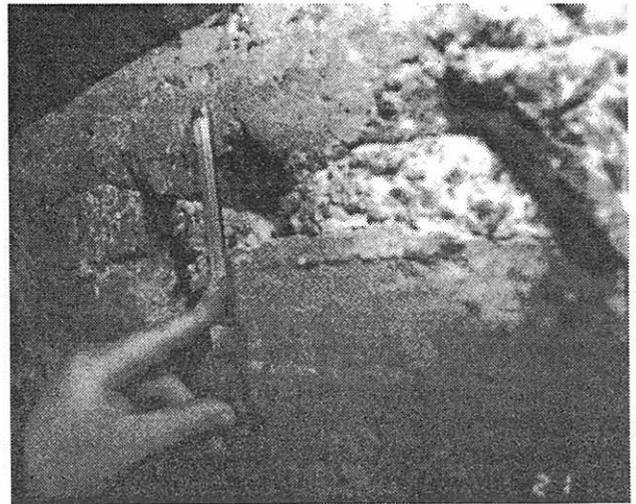
Exposed reinforcement steel and rebar corrosion as a consequence of acidification of the rebar environment caused by carbon dioxide penetration (carbonation). Photo: NEBEST bv.

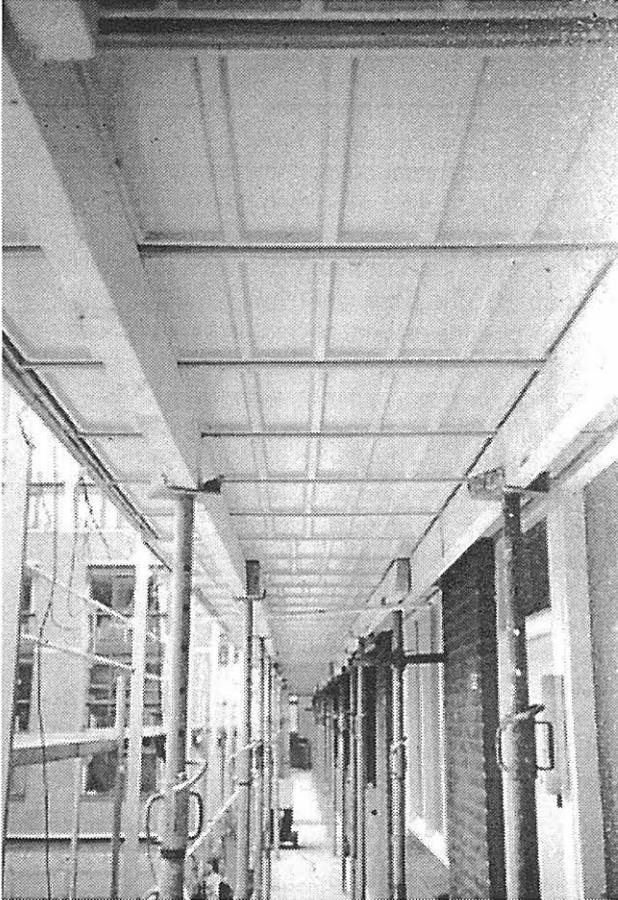
Realkalisation pans fixed onto the soffits of the access galleries in 1991.

Total charge in 1990 was $215 \text{ Ah/m}^2_{\text{concrete}}$ in 1991 it was $372 \text{ Ah/m}^2_{\text{concrete}}$. This indicates a difference in efficiency in migration of sodium ion between the fibre system and the sponge method of 2.4 to 1, in favour of the fibre system. Other factors such as temperature may be important too.

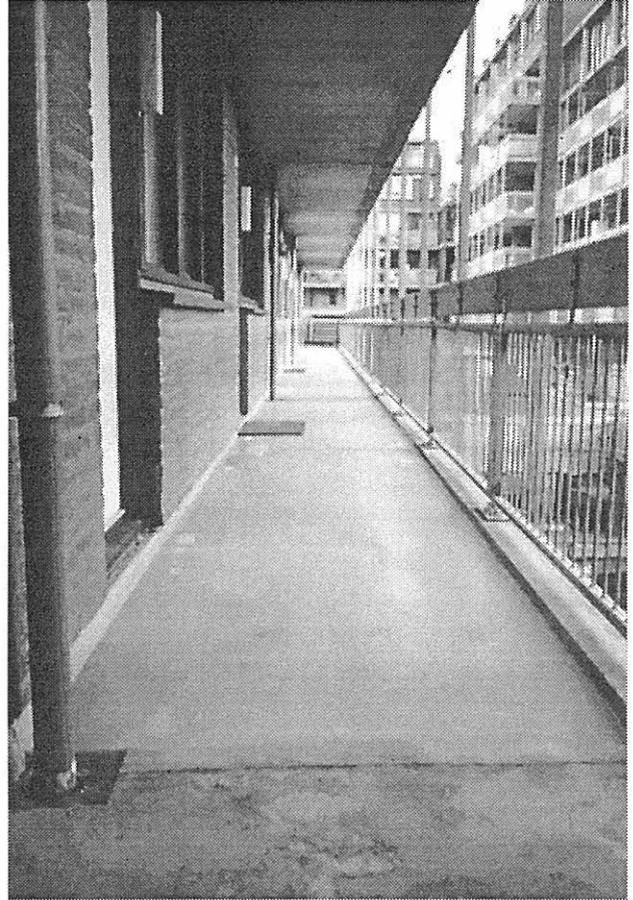
Galleries of Frederikstraat apartments after realkalisation in 1991.

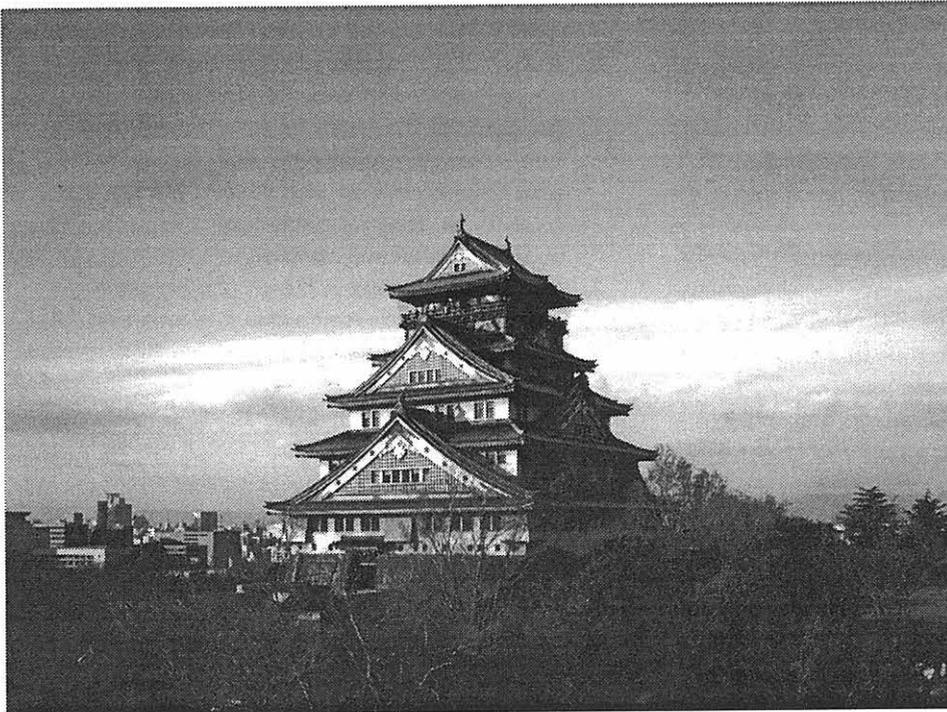
Osaka Castle in Japan is one of the most recent projects where realkalisation has been used. Photo: courtesy of Denka, Japan.

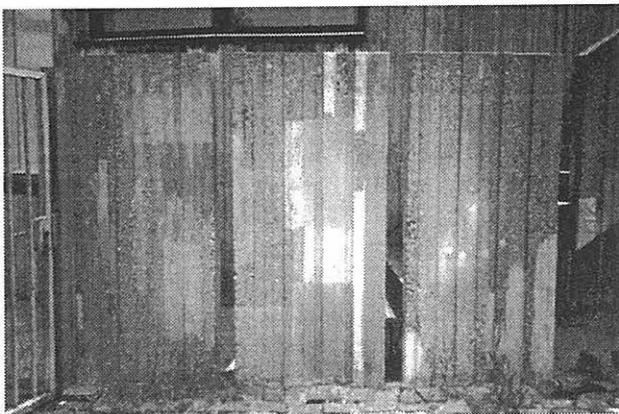
Test repairs by Sigma (left), Sika (middle) and FOSROC (right) showed a potential risk of patchwork effects, similar to previous at random repairs. Photo: K. van der Zanden. See also colour section.

samples. All three were turned down and they came back to their first demands: a matching mortar and a fully transparent coating. Frankly speaking, also my office and the invited firms themselves were not pleased with the samples. The story therefore continued, and the firms were offered a final chance to meet to the demands. This time, they were less enthusiastic in offering their help again.

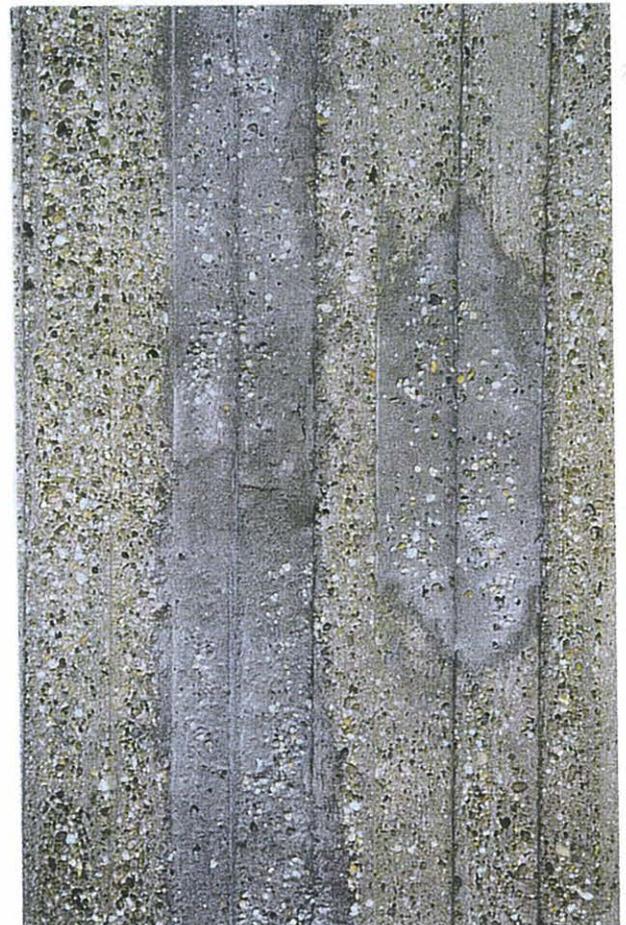
Previous patch repair of exposed concrete at Parksluizen pumping station involved materials that were unsympathetic to the original material regarding colour and texture (top, left). Three repair contractors were invited to produce trial repairs that were then evaluated by the municipal Review Committee for architecture and historic buildings; left to right Sigma, Sika and FOSROC (bottom, left). At most locations the new repairs match perfectly with the adjacent original material (top, right). The original concrete showed a natural variety in colour shades. The repair mortar was carefully designed to match the trial area but did not always meet the original colour on other locations. The finishing FOSROC Dekguard Topcoat Transparent S is virtually unobtrusive (bottom, right). Photos: K. van der Zanden and W. de Jonge.

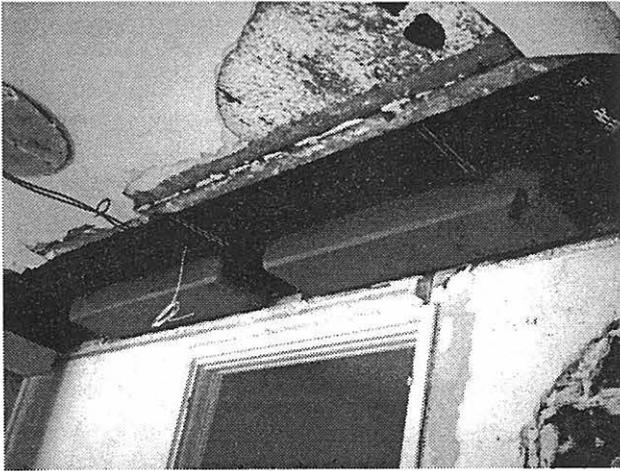
The new underfloor convectors of the main lounge on the first floor, as seen from the ground floor before the false ceilings were reinstalled. Photo: B. Baines.

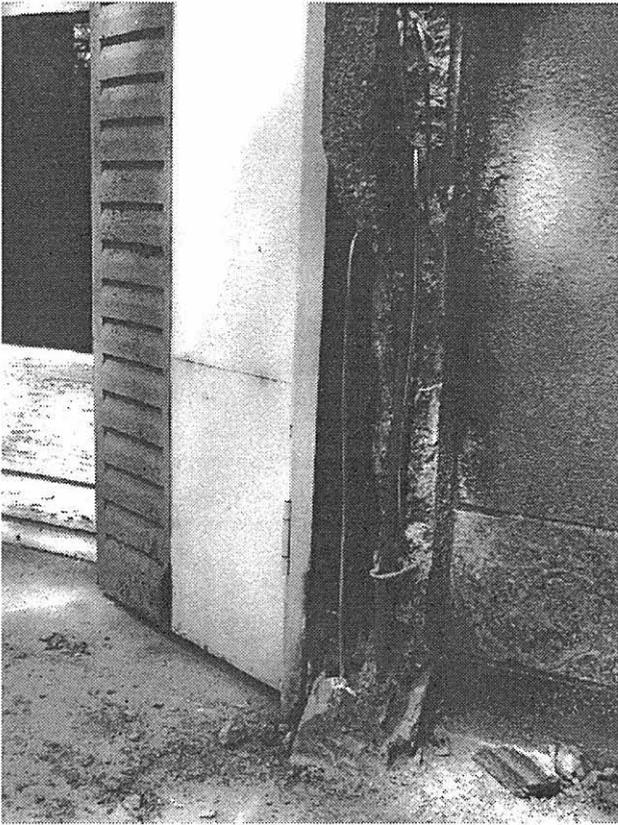
Repairing defective concrete on a window frame. The existing reinforcement element has been treated with a passivating agent, while the new ones are made of 'zintane'. Photo: B. Baines.

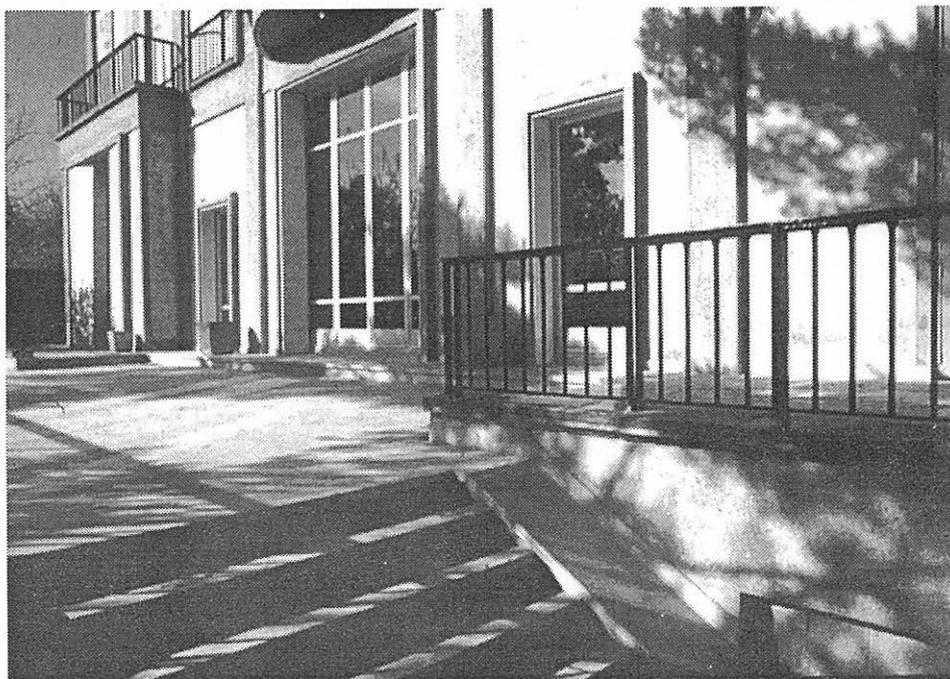
The south terrace after restoration. One of the two steps has disappeared. The new kerb is running all along the south wall, against the stone slabs and the low ends of the concrete window frames. Photo: B. Baines.

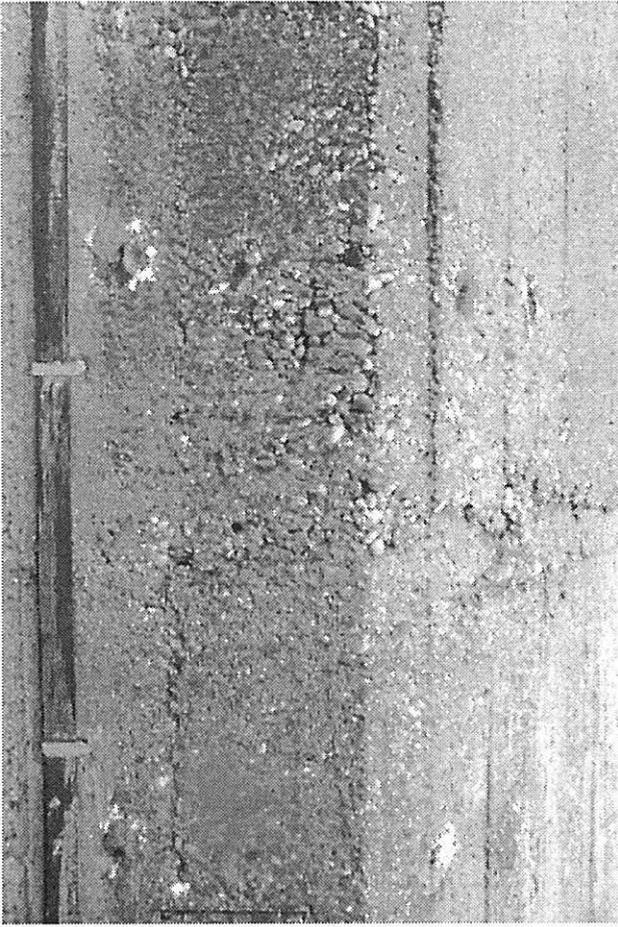
The original concrete has not been vibrated and aggregates are poorly enclosed by concrete mass, The exposed surface is board marked both outside and in the interior.

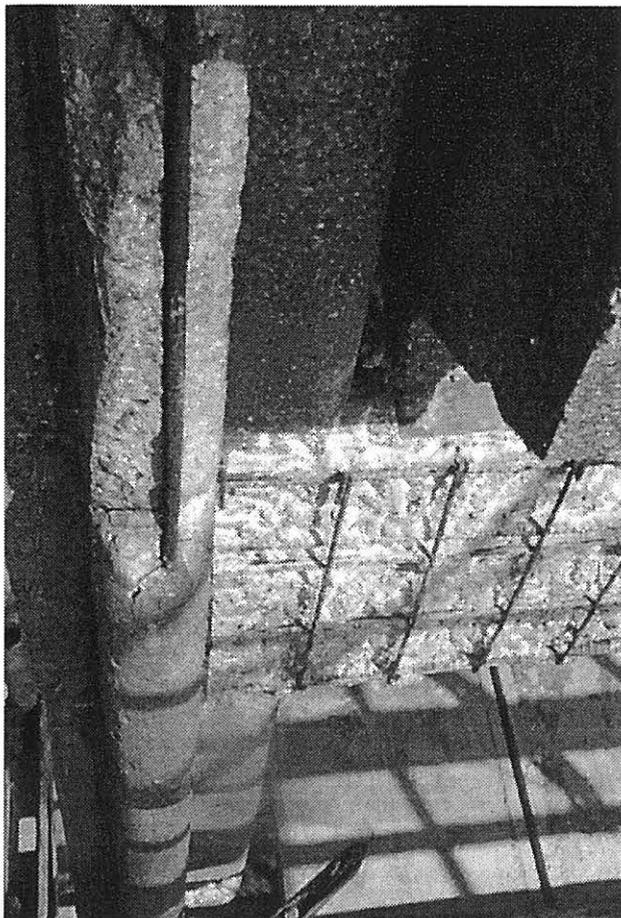
The concrete frame of the belfry suffered from serious failures: exposed steel, open cracks and spalling of concrete, especially at the connections between members. The lower corbels that supported the belfry were expected to have suffered most. The wooden blocks on the supports appeared to have been reduced to thin wedges. The restoration of the belfry consisted of the repair of the reinforced concrete structure and the replacement of all the deteriorated elements. The first works done on the concrete concerned locations that were not visible from the outside. This way we got the chance to define more precisely the remedial treatment for the restoration of the concrete surfaces, the quality requirements to be made to the formwork, the mortars to be used for patch repairs, and the selection of proper granulates. Calculations of the stability of the belfry showed that it was placed eccentrically on its foundations and that the entire structure of the tower was slightly slanted towards the west mainly due to the weight of the louvre-boards. It was decided to reinforce the belfry, which was necessitated by the static requirements to accommodate the bells, and by doing so, to slow down the deterioration of this part of the building. Additional static elements like prestressed cable, or frames of IPE steel profiles, as were recommended by the studies and calculations of the technicians, would have completely changed the original character. Therefore, we decided not to modify anything but to add a new and completely independent timber structure inside the lower part of the tower. In addition, we changed the axis of the bells to a new direction, along the longest span, so that the belfry

would be more appropriately loaded. The corbels projecting out of the concrete columns were remade and covered with neoprene to mute certain frequencies mechanically.

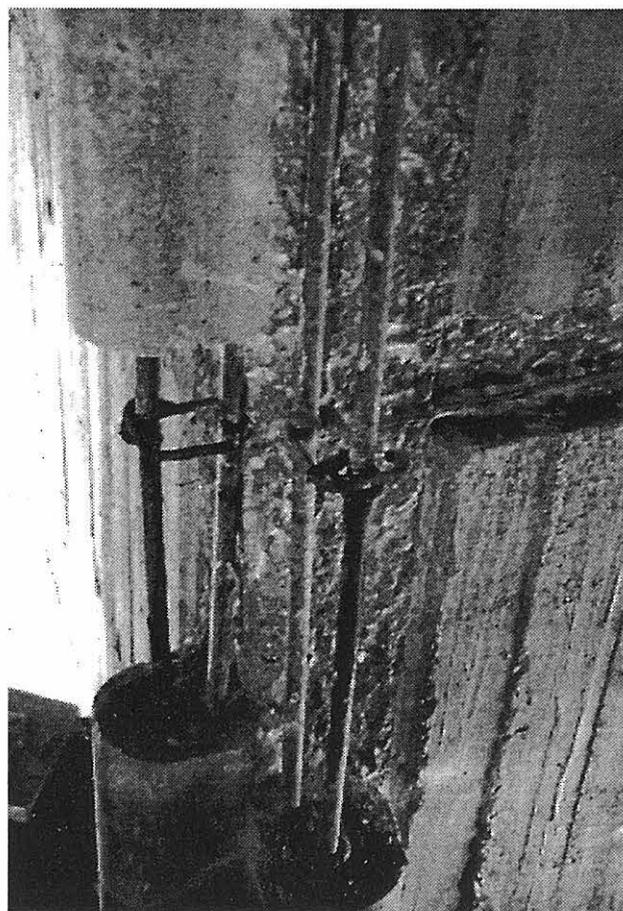
Top and left: Small scale repair work with custom mortars were performed at the thin columns of the tower.

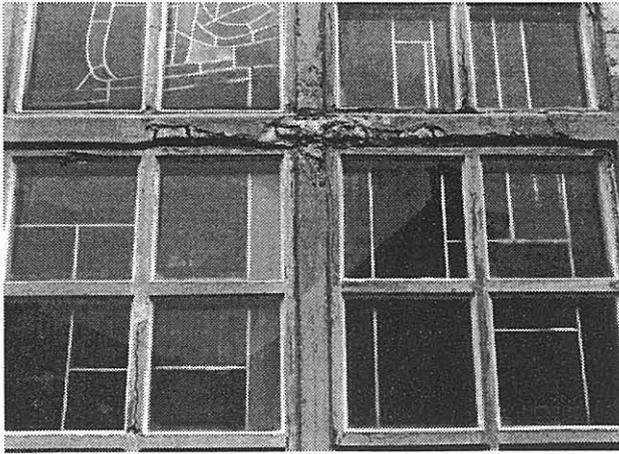
The structural safety of the window frames was reduced beyond repair due to major spalling. Photo: C. Baur.

form of concrete spalling was found on the outside portal over the main passage in the lateral facade. Apart from the scheduled restoration work, loose concrete pieces had to be immediately removed from this location as a safety precaution for passers by. The window mullions and transoms had suffered considerable deterioration on the exterior. Almost all patches applied in 1962-63 had again chipped off. Because of this, the load bearing capacity of the window frames was rendered insufficient. All damage had been due mainly to carbonation of the concrete which was advanced through the relatively high porosity of the material as well as by ecological conditions.

Other structural elements, such as the walls of the entrance portal, were less critical. On the other hand, the window members (mullions and transoms) were so badly deteriorated that the required safety factor could not at all be guaranteed.

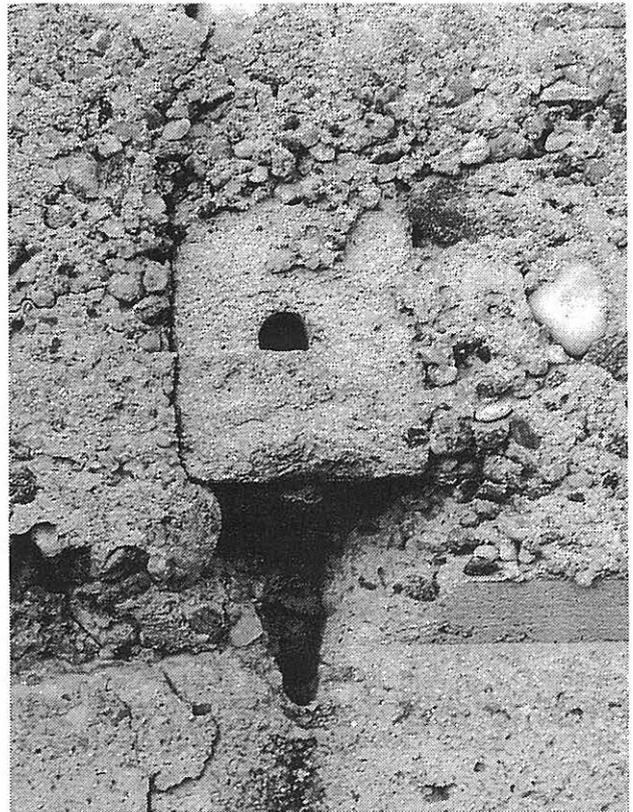
An area subject to concrete spalling parallel to reinforcement steel, due to carbonation of the concrete.

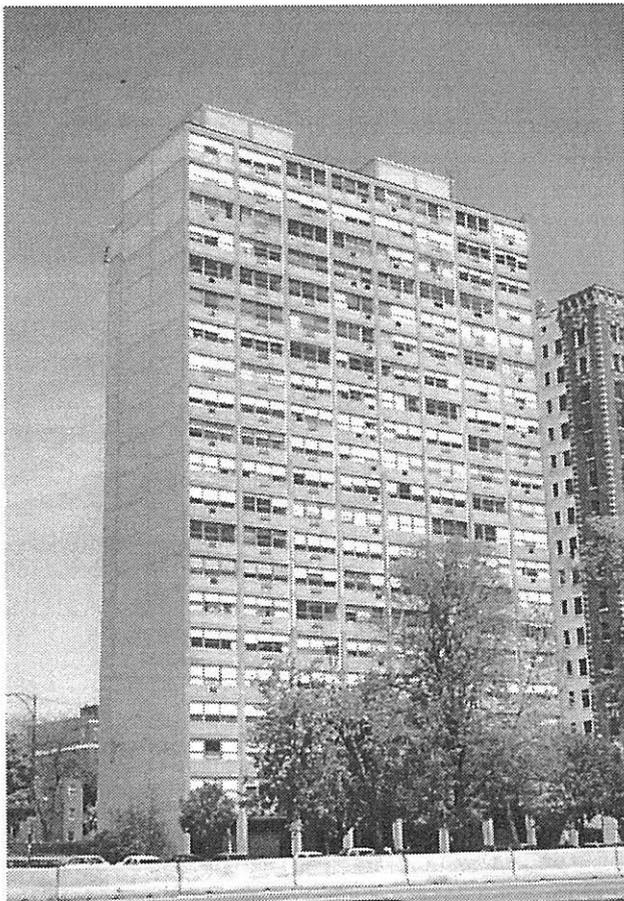
Front and side elevations of the Promontory apartment building. All illustrations by P. Gaudette, except where stated otherwise.

The 21-story Promontory apartment building¹ (1949) is typical of the postwar trend toward straightforward design with an emphasis on efficiency, low cost, and expression of structure. The exposed reinforced concrete frame of the building is infilled with light-colored brick panels. The concrete frame is emphasized by the projection of the columns beyond the exposed floor slabs. The windows are aluminum-framed; this is an early architectural use of aluminum following the popularization of this material for wartime aircraft construction.

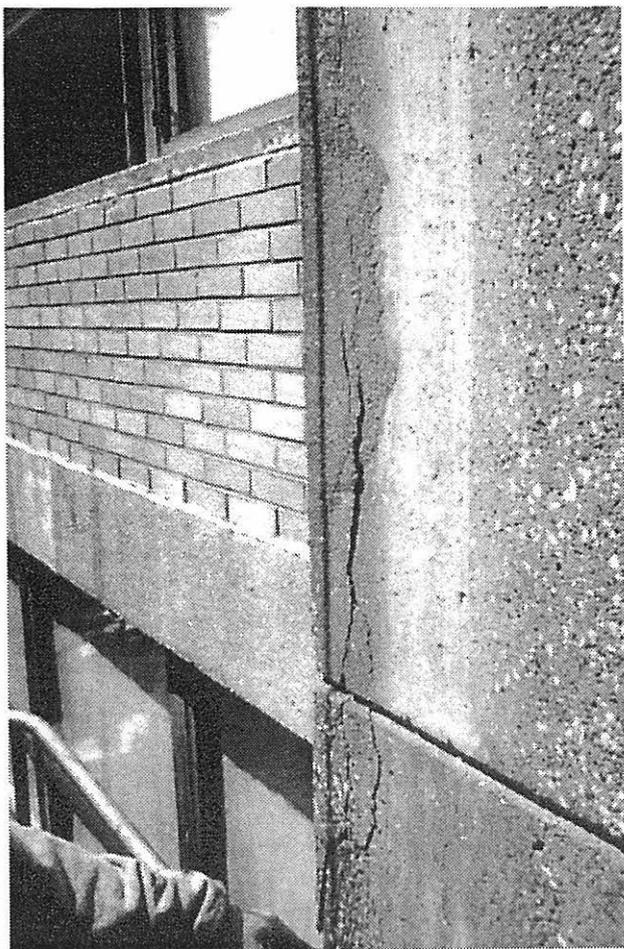
Previous repair involved darker epoxy-based mortars. Since repair was installed only to the level of the reinforcing steel delamination occurred in these areas. See also color section.

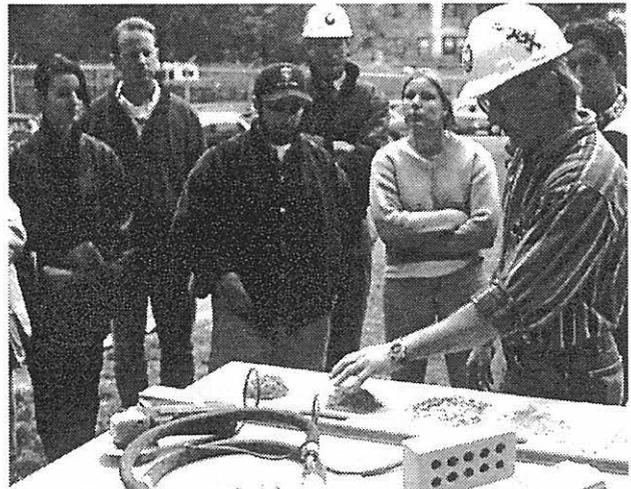
Composing a matching concrete mix on site, employing local sand, aggregates and a buff-colored cement which was hard to obtain. Photo: W. de Jonge.

Approximately twenty, 1 foot square samples were prepared in forms, separate from the building. The

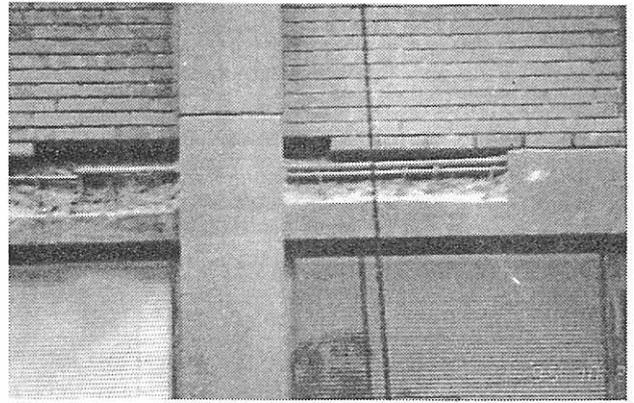
Completion of the preparation work in a repair area prior to installation of formwork.

Surface preparation is one of the most important components of any concrete repair. The steps

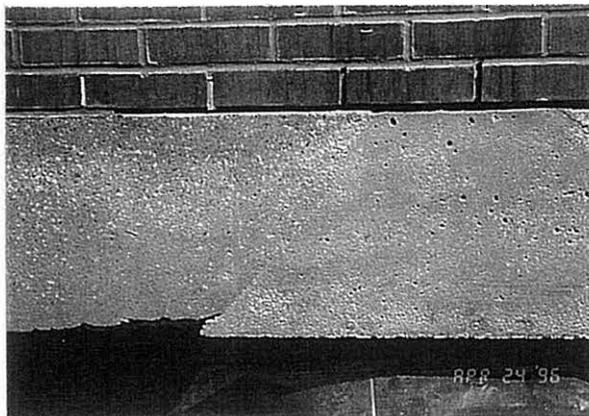
Previous repair of exposed concrete at the Promontory apartment building involved a darker epoxy-based mortar; major delamination was found at such locations (bottom, right). Trial repair mix samples adjacent to the original facade show slight variations in colour and texture to match the original material (left). The complete installation of repair and finishing at a spandrel beam shows the careful match between repairs and original material (bottom, left). Photos: P. Gaudette.

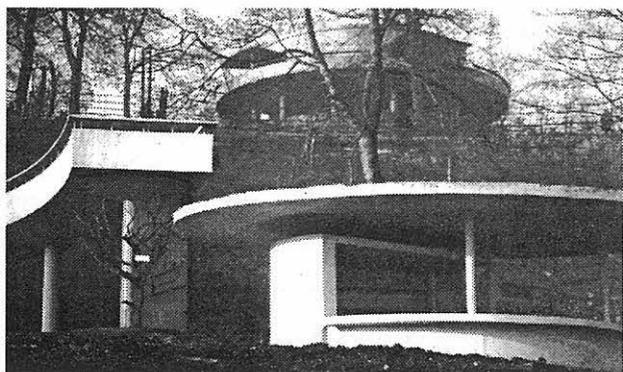
Quick, cheap, small and sculptural. Lubetkin's early use of reinforced concrete in the zoo. All photos: J. Allan, except where stated otherwise.

early 1930s -that is thin-wall fairface monolithic design, or what Ove Arup was later to call 'muddy structure' on account of the fact that, as he put it, 'although you can ensure that it is perfectly safe, one doesn't know exactly how the stresses are distributed'.

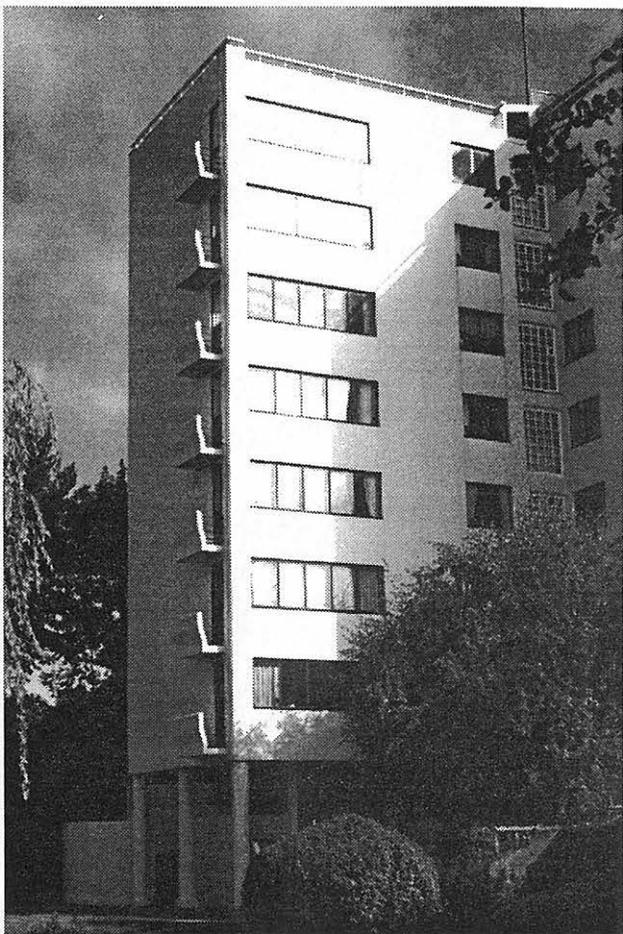
Highpoint One, 1935, where fairface concrete structure is fused with architectural expression to produce a 'jointless aesthetic'.

Like the zoo buildings, Highpoint was highly engineered in structural terms, benefiting as they had, from the assistance of Ove Arup whose use of a sliding shuttering construction system for the monolithic reinforced concrete carcass meant that the external expression and the structural realization of the building effectively became one and the same thing.

This was the first and last time Lubetkin and Arup used external load bearing walls (or 'eggshell structure') as the overall structural solution in a large housing scheme. As their work develops so the distinction between structure and expression is made increasingly clear. At Highpoint Two (1938) for example, the structure is a hybrid of frame and load bearing external wall which produces an architectural response of infill and cladding respectively. Even in the later zoo buildings Lubetkin was using materials such as brickwork or terrazzo panels as a means of wall-facing that avoided large areas of exposed concrete.

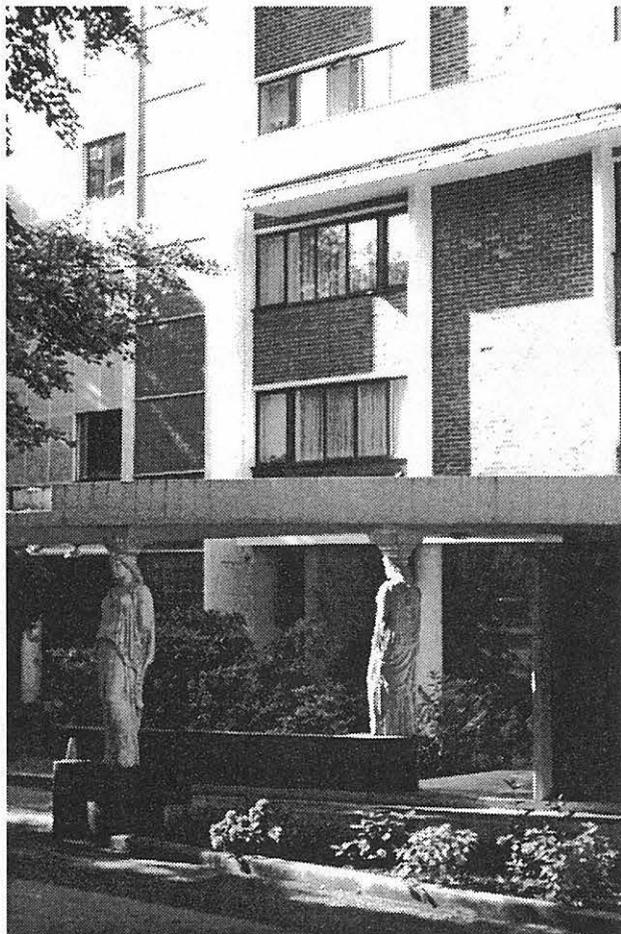
Highpoint Two, 1938, where frame and load-bearing structure results in infill and cladding - an aesthetic of articulation.

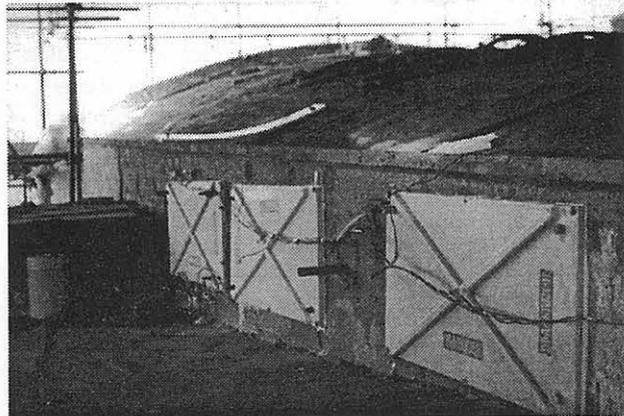
Realkalisation being applied to the lateral walls at the barrel roof.

Anyway at Finsbury we used both, albeit with the bulk of the repair being through realkalisation. The following illustrations show how the realkalisation technique was tailored to the specific architectural features of the building. Some traditional repair was still required, generally where small areas with unusual profiles made realkalisation uneconomic, like the distinctive ventilation funnels at roof level. This is also the point to talk about colour. All render and concrete surfaces above basement level had been overpainted white during subsequent maintenance. By studying contemporary black and white photographs and removing later applications of paint and render it was possible to retrieve the original surface colouration. A typical Tecton palette of colours was discovered: intense red-brown applied to selected surfaces on the terrace; pale blue to the reveals of the glass block entrance screen, terrace canopy soffit and lecture theatre block, a dark 'French navy-grey' to basement and undercroft areas, and a cream colour elsewhere. On completion of concrete and render repairs, surfaces were re-coated with closely matching colours from the Sika and SBD concrete repair systems.

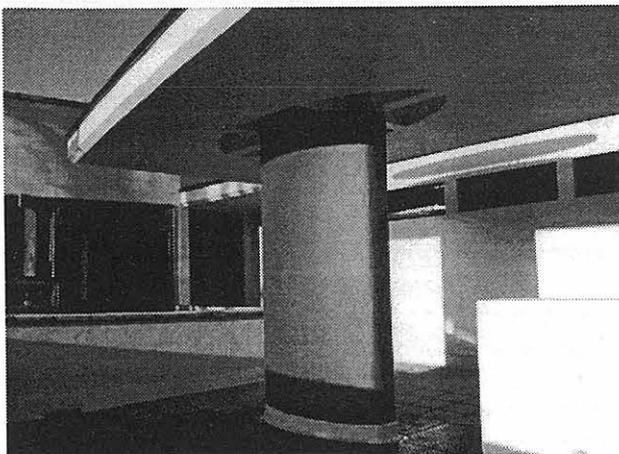
Traditional concrete repair techniques used locally for difficult profiles.
