Restoring Postwar Heritage

preservation technology
dossier 8
August 2008

Theodore H.M. Prudon FAIA
Kyle Normandin
Editors

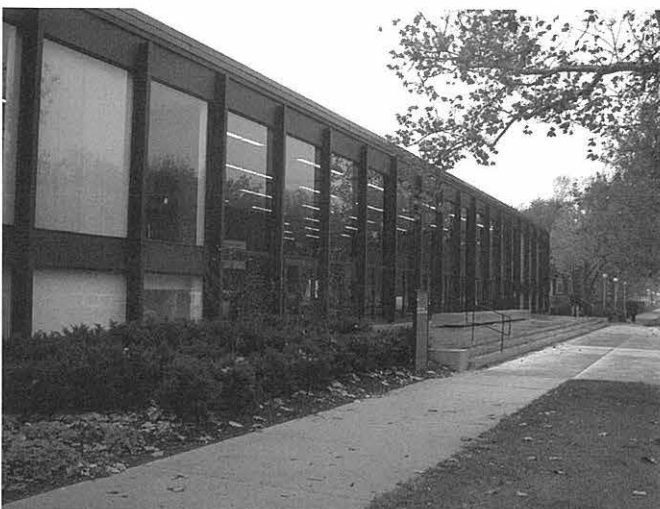
The School of Social Service Administration (Ludwig Mies van der Rohe, 1965) has experienced glass breakage from corrosion of steel elements.

The School of Social Service Administration has experienced glass breakage from corrosion of adjacent steel elements, which is related to condensation on the interior and water infiltration through open joints in the framing and glazing. The use of glass units in steel frames and the associated problem of glass breakage from corrosion of adjacent metal is not unique to this design or to modern buildings of similar design and materials. However, the problem is complicated here because of the large size and extent of the glazing units, and their importance to the design intent and original aesthetic. Any changes to the materials or details of the window frames glazing would affect the appearance of the facades. The curtain wall glazing on the Law Quadrangle Library has been replaced previously with insulating glazing units to provide improved energy efficiency. The similarly extensive curtain wall at the School of Social Service Administration retains its original single glazing, and alteration of these units would likely not be acceptable.

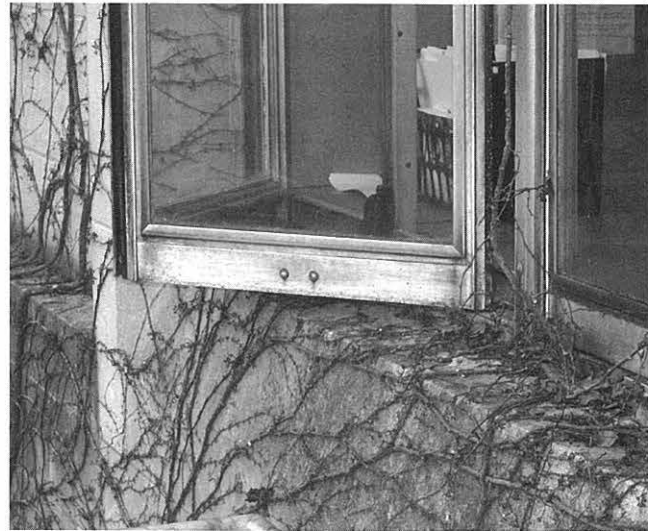
The unusual bi-fold windows at the Administration Building require frequent repairs. Parts are no longer available

At the Administration Building, the unusual bi-fold aluminum windows require frequent repair due to breakage of the operating mechanism. The windows are no longer manufactured and the university has considered various options ranging from replacing the windows with new operable units to retrofitting the existing units as fixed units, rather than continuing to repair and maintain the existing window units in operation. These options present different implications for maintaining the design intent and aesthetic of the building facades, and for meeting varying requirements of the university program, building users, and facilities staff.

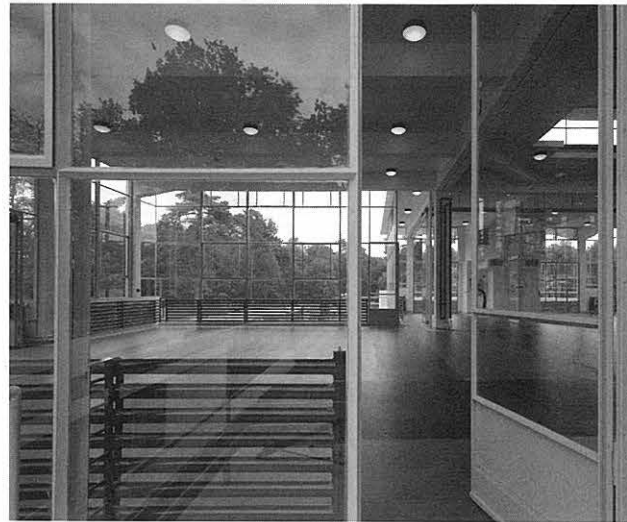
Carefully reconstructed parts such as the steel window casements, the sheet glass and the linoleum floorings. (Photo: Jannes Linders)

Given the great historic and architectural qualities of the transparent enclosure of the building, it required serious efforts to find types of glass that would be truthful to the perception of the original. Predating the invention of float glass⁷, the drawn sheet glass as used for 'Zonnestraal' was slightly warped, producing vertical distortions, which was essential to the vision and reflection qualities of the state-of-the-art curtain wall of 1928.

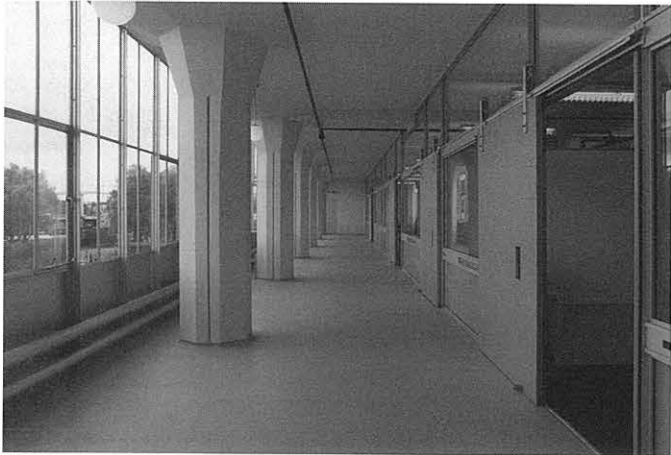
At the shadow-side, the secondary glazing is located at some distance from the original facade leaving enough space for corridors. At the other side, the sun side, the glazing has been placed between the columns, corresponding with the position of the original sunshades, creating a climate-regulating wall. (Photo: Fas Keuzenkamp)

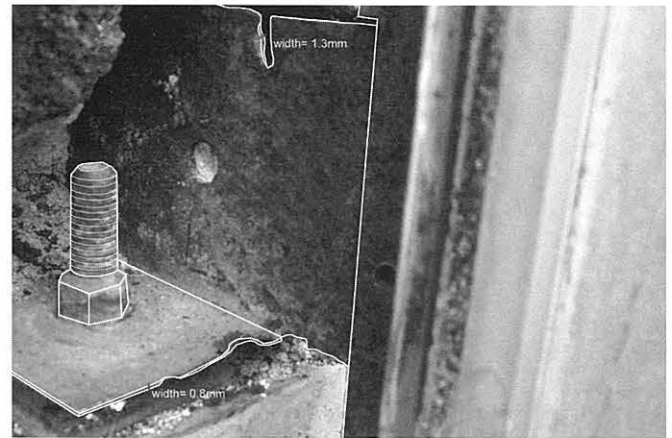
Failed Anchor

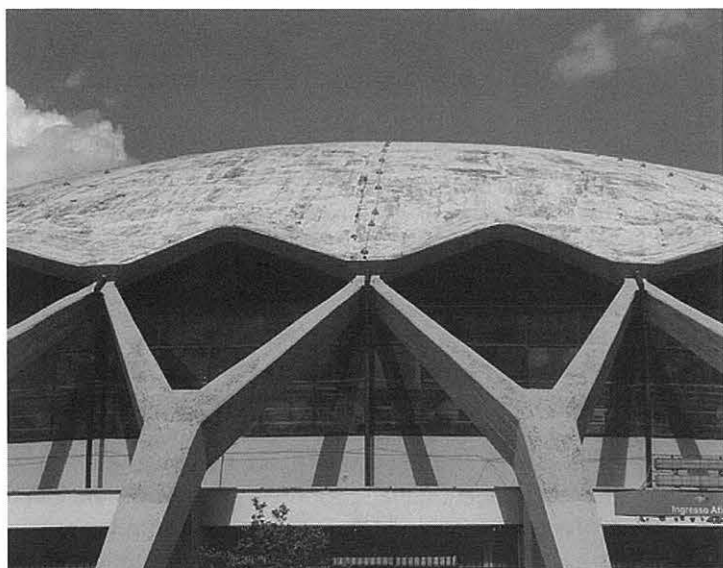
View of Nervi's concrete Y-shaped trestles, Sport Palace, Rome.
(Photo: Sarah Rinehart)

The ground floor of the construction has two levels of tiers. The main structural problem of the construction was the necessity to cover the circular space of almost 100 m in diameter without intermediate pillars. The solution was to put a dome as a covering; however, this involved the question of how to balance the prominent horizontal forces at their impost floor. Given the presence of a very good foundation soil, the most natural and economical solution seemed to be that of bringing, via suitable structures, the actions of the dome directly to the ground. The dome is formed by a wavy structure completed at the upper level by a slab with only 9 cm thickness. The waves are formed by prefabricated elements of the same type of the ones in the Expositions Palace. In this way a system of ribs, connected together by the final slab, is formed by creating a highly resistant structural system. The system achieved is iperstatic. The corrugated dome can be interpreted as a membrane or as a series of

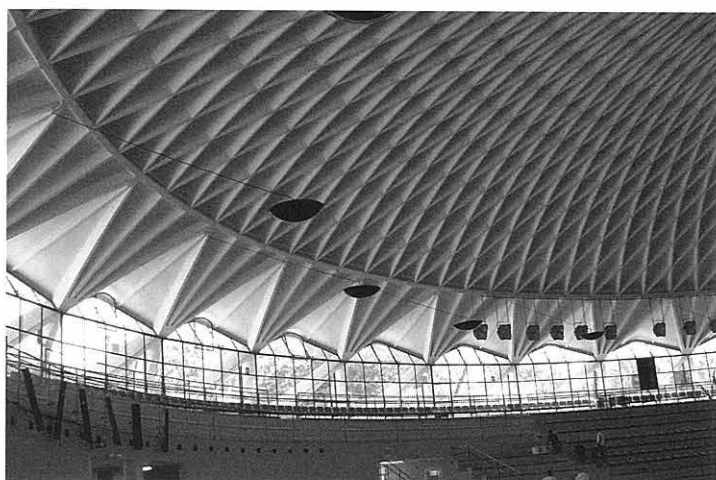
View of interior ribbing. (Photo: Francis Jonckheere)

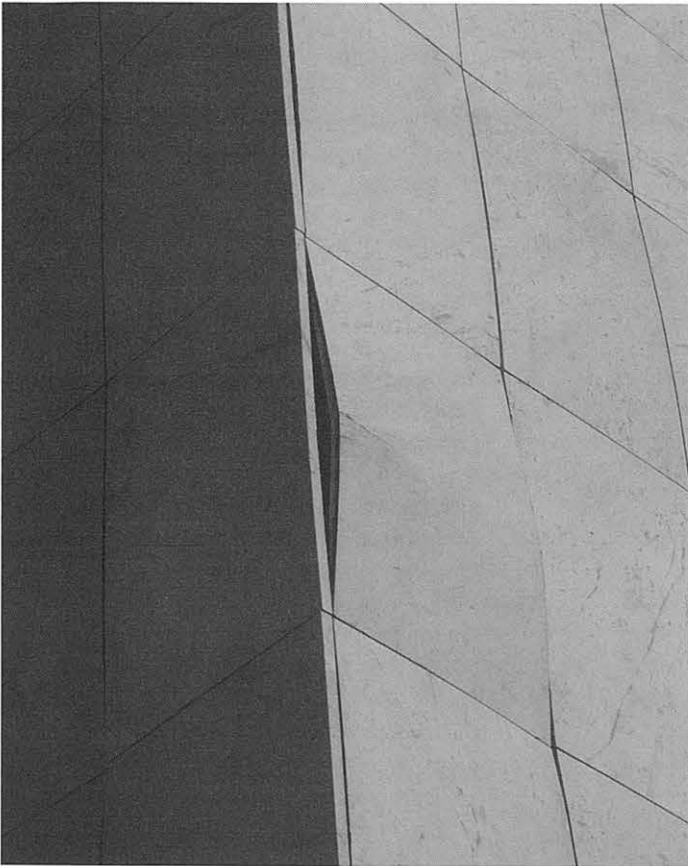
*Detail of deteriorated marble on a hotel, Helsinki.
(Photo: Björn Schouenborg)*
